# Historic Structure Report

Boston Carnegie Library  
250 South Main Street  
Boston, Thomas County, Georgia

Eric Menninger  
*EAM Preservation – Atlanta, GA*

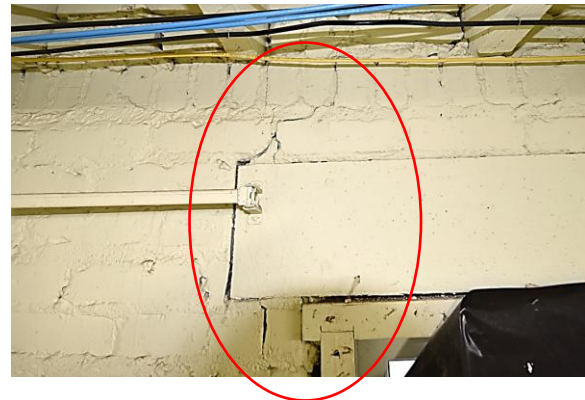
A full evaluation of the historic foundation was impractical given its depth and the finished walls in the basement. In one area where access was possible, however, a crack was noted above the rear window along the northern basement wall.

② The failure of mortar and the vertical fissure in the brick here suggests a shift in the load dynamics of the wall which could indicate a failure in the foundation. It is also possible the crack was caused by stress to the window opening and movement of the window header due to moisture invasion from the exterior. Examination of the wall below grade could answer this.

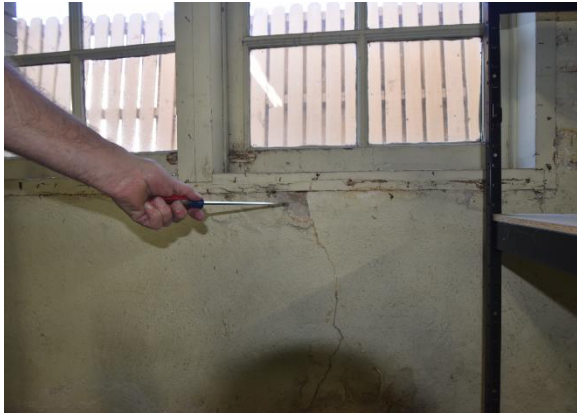
This appears to have been caused by water entering below the wooden sill and gradually degrading the condition of the stucco coating on the interior. It could not be determined if the masonry wall behind has been impacted by this water invasion. At present, this does not appear to be an active leak as the site was dry during evaluation.

*Fig.II.7 Failure in concrete skim coat below window may indicate foundational damage but likely caused by water invasion below sill.*

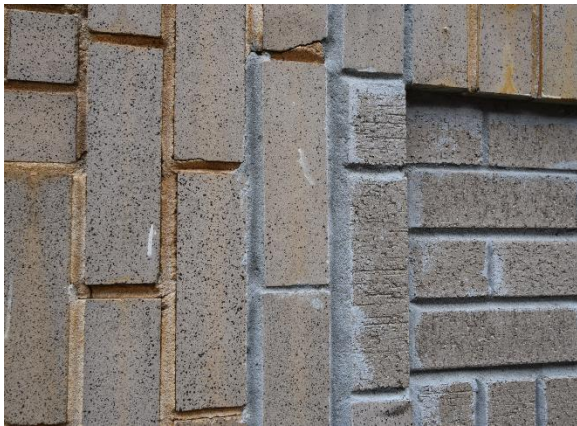
As a part of this modification, a section of the water table was repointed (repaired) with a Portland cement mixture. Modern Portland based cement mortar is brittle, has low permeability and is harder than the historic brick which makes it is very difficult to remove without causing damage. A lime-based mortar with color matching would have been the sympathetic repair.

*Fig.II. 31 Patching (repointing) to the water table brick above the ADA doorway used unsympathetic Portland based cement mortar.*

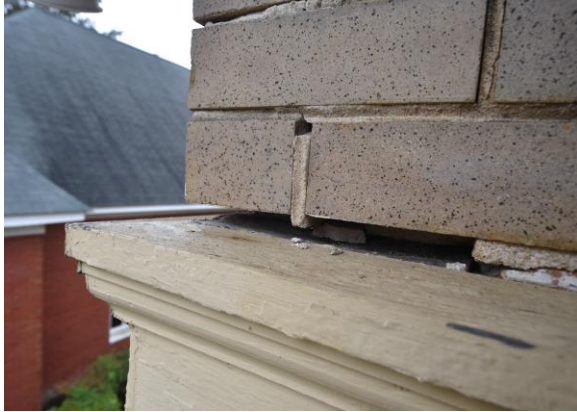
② While the structural integrity of the exterior walls is good, there are numerous places where long term moisture invasion has caused damage to the historic brick and mortar. The most widespread problem is mortar recession – meaning the retreat or disappearance of a sound mortar joint between the bricks.

*Fig.II.37 Above architrave in southeast corner.*

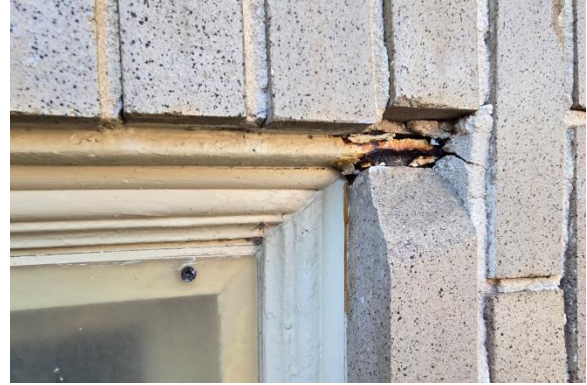
*Fig.II.40 Fractured brick and iron jacking above basement window east elevation.*

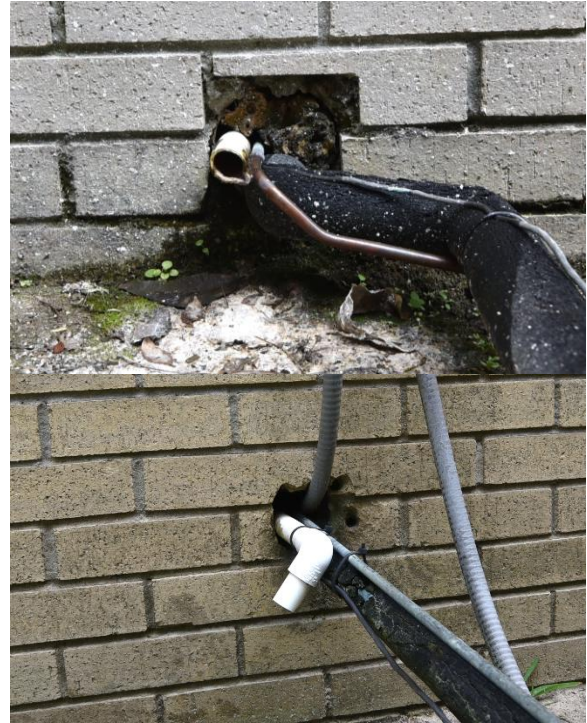
① There are two penetrations (holes) in the exterior wall. Both are located in the southwest corner of the Modern Addition Walls. These appear to have been punched through for various HVAC lines. While the holes appear small, they are more than big enough to allow small critters and reptiles to enter the basement cavity. Both of these should be properly sealed with a lime based mortar. **Do not use spray foam to patch these openings because its removal is nearly impossible.**

*Fig.II.44 Holes in the foundation on southwest corner of the building.*

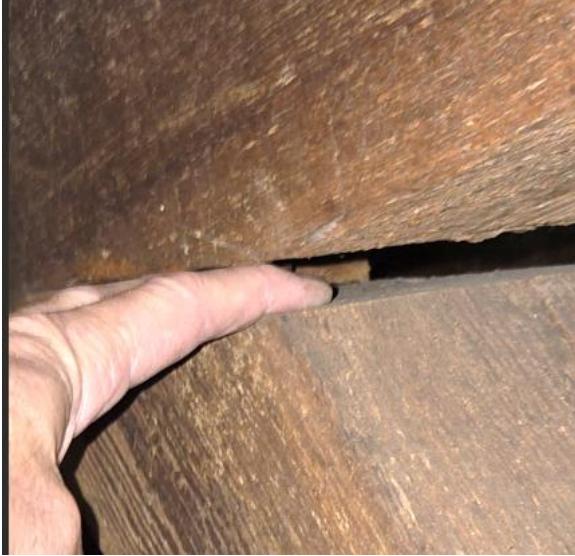
*Fig.II. 77 The truss webbing has pulled away from the upper chord on both sides.*

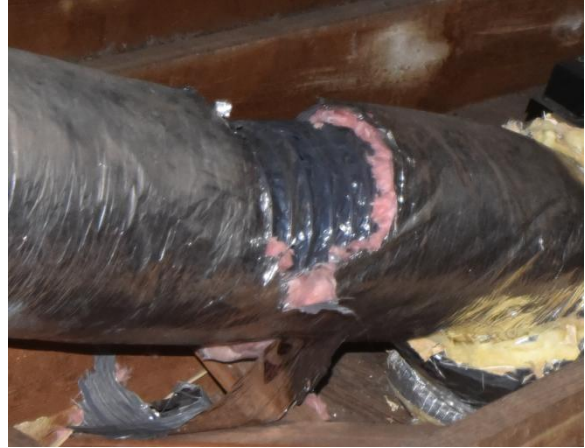
There was some evidence of critter infestation, but no live sightings were made during inspection. Several areas of HVAC insulation appear to have been chewed away as only a squirrel can do but no obvious entry points were observed on the exterior of the building so this may be a past problem.

*Fig.II. 79 Damage from critters to HVAC duct insulation, probably squirrels, was observed in attic.*

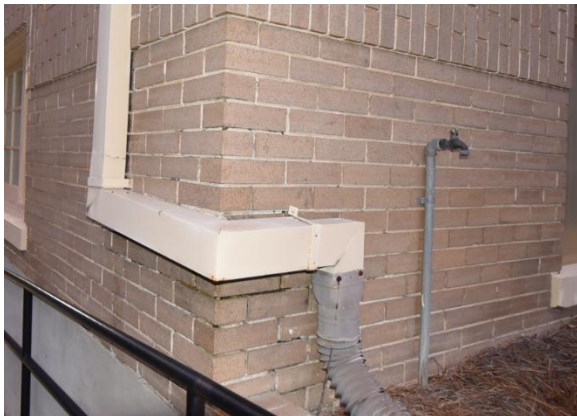
The downspouts serving the front corners have been configured to direct rainwater into the soil along the east elevation of the building. As will be noted below, this is having a detrimental effect on proper drainage and is rapidly damaging the building.

*Fig.II.87 Front downspouts have been re-routed to direct water into ground on east elevation.*

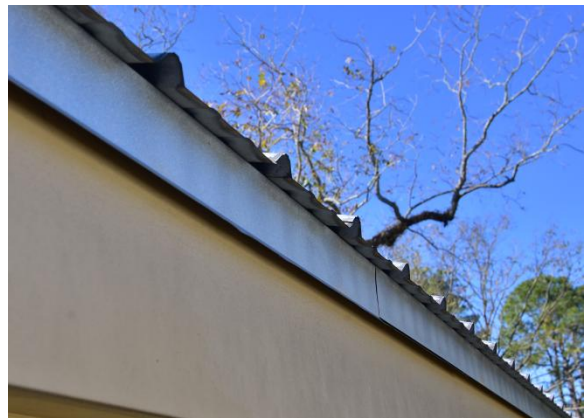
*Fig.II.89 Several roof facets have no drainage system, only an overhanging drip-edge.*

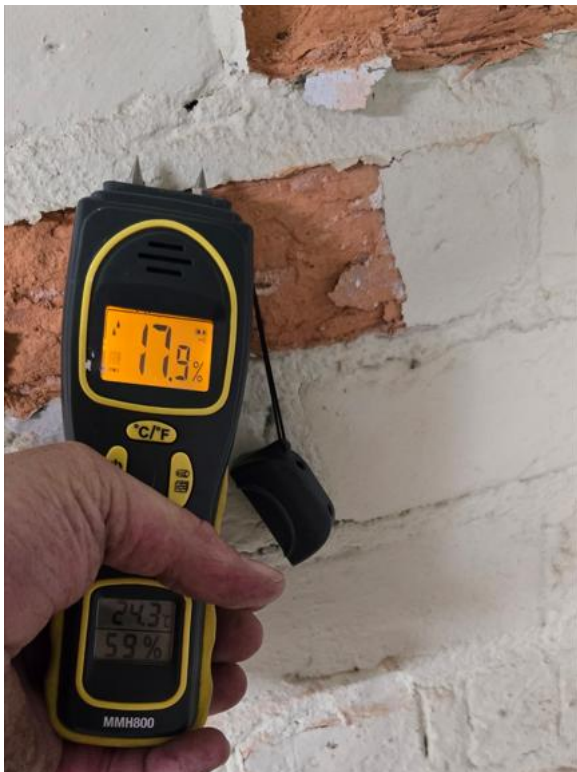
*Fig.II.95 Moisture readings on the interior are very high.*

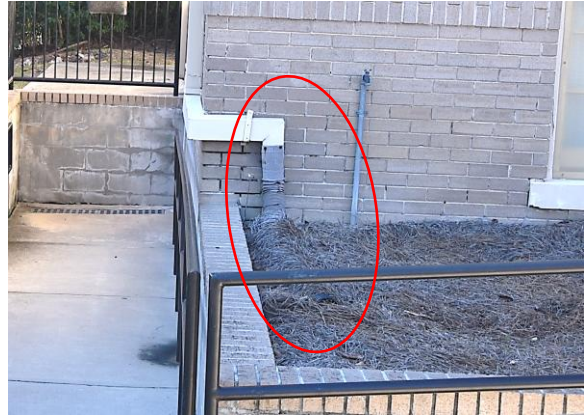
*Fig.II.96 Rain runoff on south end of east elevation is trapped by ADA ramp and wall.*

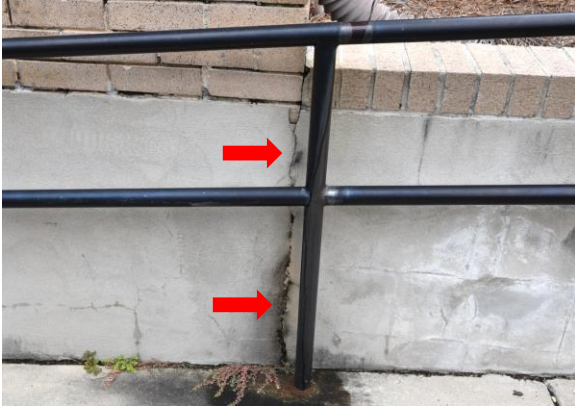
*Fig.II.98 Complete wall failure due to poor drainage is underway.*

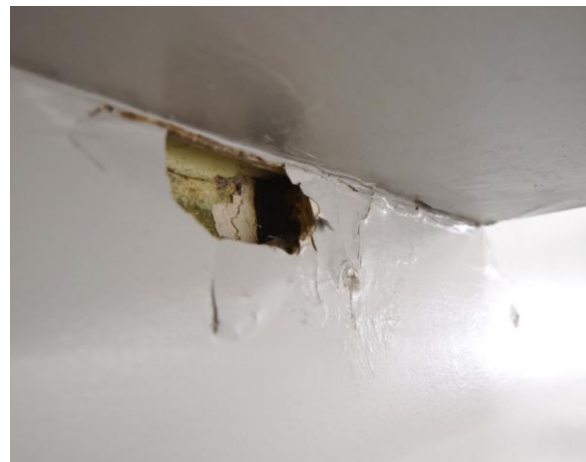
Fig.II.108 Extensive gypsum board failure below entryway in basement.

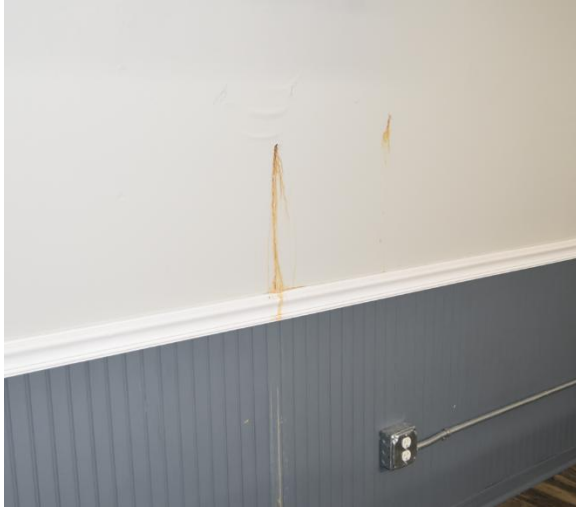
*Fig.II.109 Rust stains are bleeding through from moisture trapped behind the wall board.*

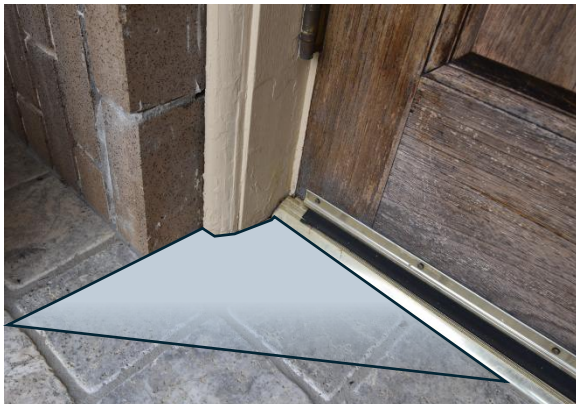
*Fig.II.110 During rain events, water is pooling up on the outside of the threshold because the stoop is slope down and inward here.*

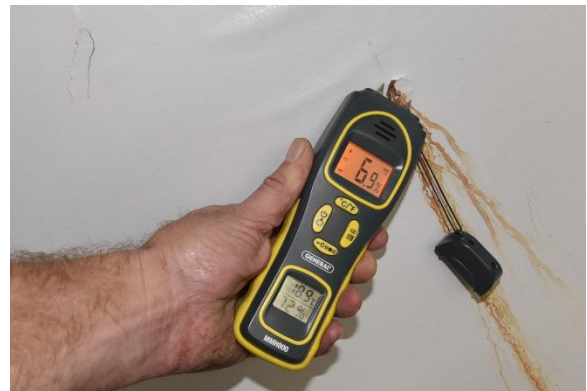
The second area of concern is along the stairway wall to the basement. An active source of moisture is damaging the plaster finish here causing it to separate from the brick. The cracks and blisters indicate the problem is widespread along this section of the wall. Multiple moisture readings revealed a mix of high rating between 13.4% and 17.7% - very high for an interior wall such as this.

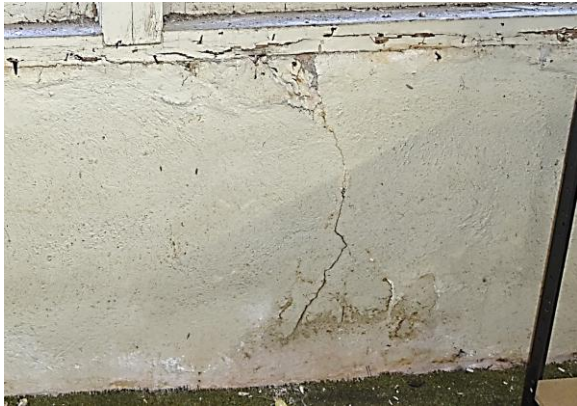
Fig.II.115 Water damage to interior wall along north side basement.

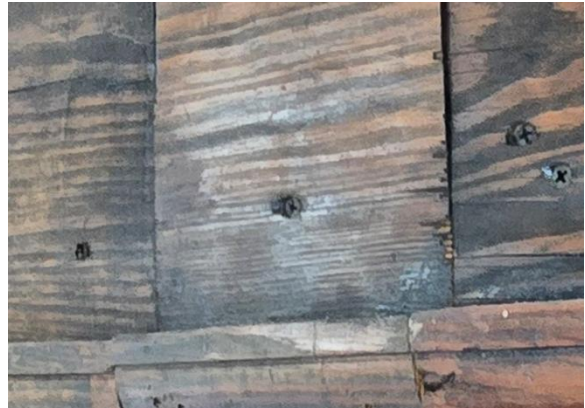
*Fig.II.155 Repairs to the beams were fastened with drywall screw in a hasty arrangement.*

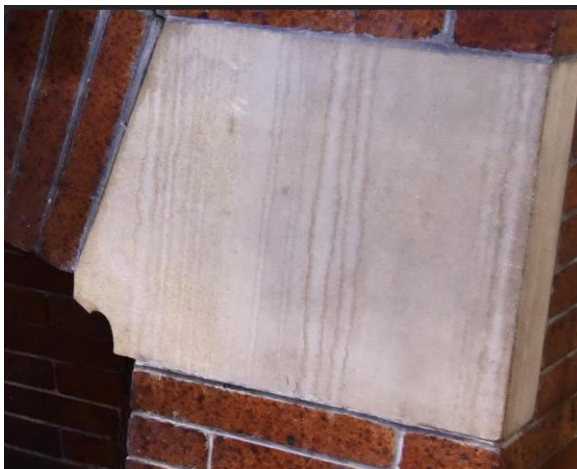
*Fig.II.158 Water staining on northside fireplace.*

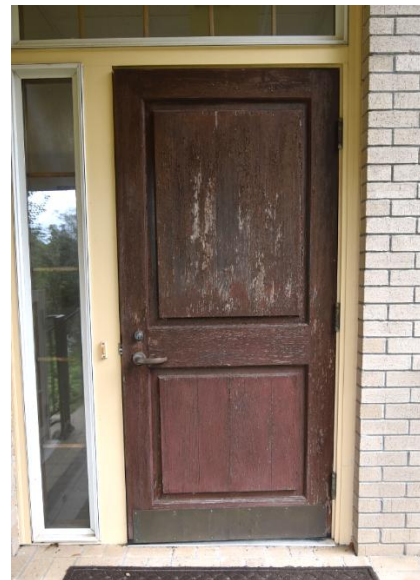
Fig.II.184 Exterior rear door needs refinishing.

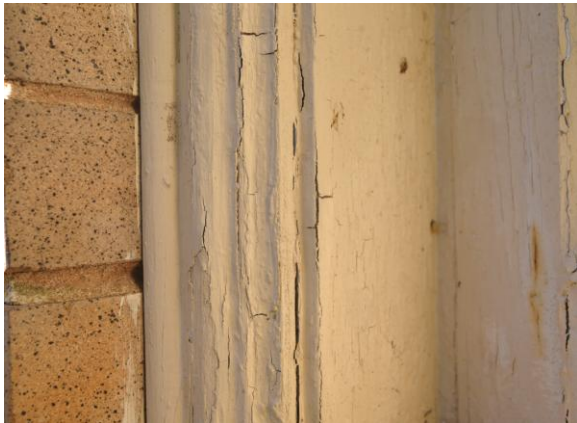
*Fig.II.207 Various types of paint failure was observed.*

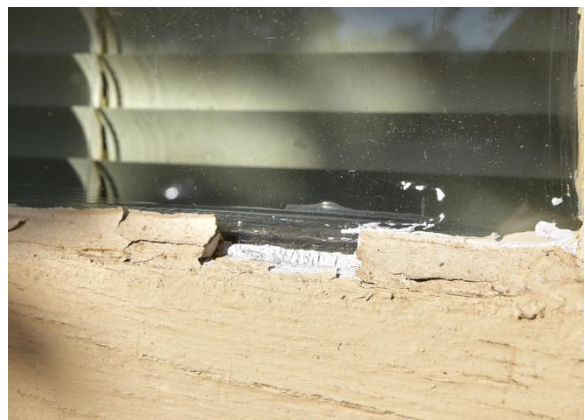
*Fig.II. 210 Many windows have failing glazing (putty seal on exterior).*

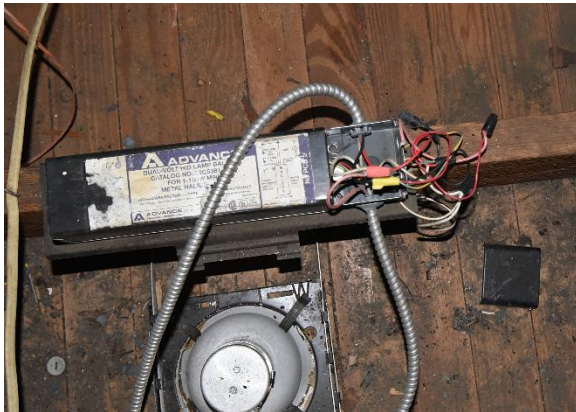
Fig.II.247 Many of the junction boxes on the HID ballasts are not properly covered.

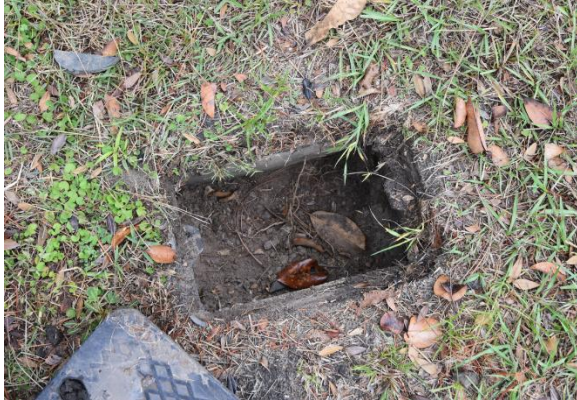
Fig.II.262 Water main hook-up inaccessible due to accumulated dirt and debris.
