# Historic Structure Documentation and Existing Conditions Assessment

## Caretaker's Cottage

Booker T. Washington Park  
233 Orange Avenue, N.W.  
Roanoke, Virginia

July 2026

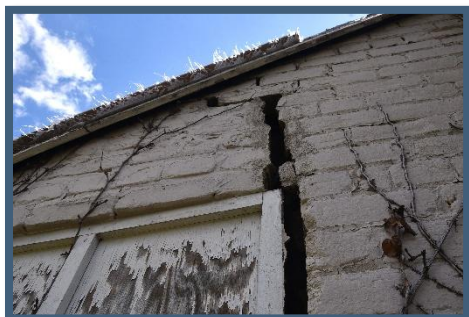
West end gable failure - north crack.

Preservation should prioritize emergency stabilization followed by a carefully documented rehabilitation. The exterior masonry walls should be temporarily braced, and foundational weaknesses, structural movement, and damaged wall sections should be evaluated and repaired by qualified preservation professionals. Where character-defining elements must be removed to permit stabilization, each component should be photographed, measured, labeled, and then carefully disassembled and stored for repair and reinstallation.

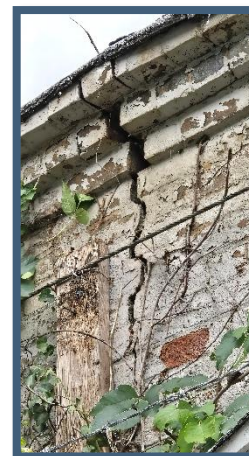
South wall failure - mid span @ cornice.

N/W CORNER  
3 1/2" OUT @ 14'

S/W CORNER  
2 1/2" OUT @ 14'

LOWER WALL  
BELLING

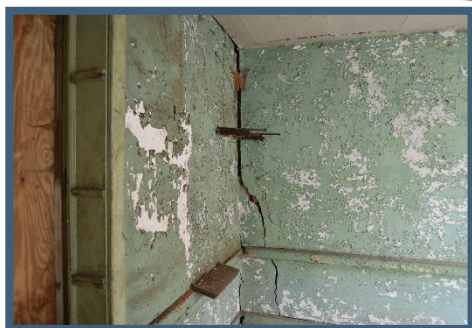
North wall separating from interior dividing wall.

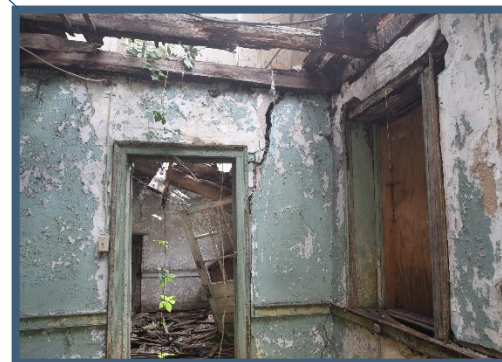
South wall separating from interior dividing wall.
