# Historic Structure Report

Boston Carnegie Library  
250 South Main Street  
Boston, Thomas County, Georgia

Eric Menninger  
*EAM Preservation – Atlanta, GA*

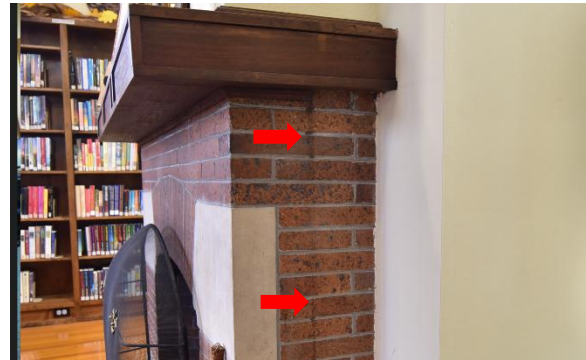
Sec. I/ Fig. 29 Ghost lines of wall bookshelves (red arrows) along chimney side.

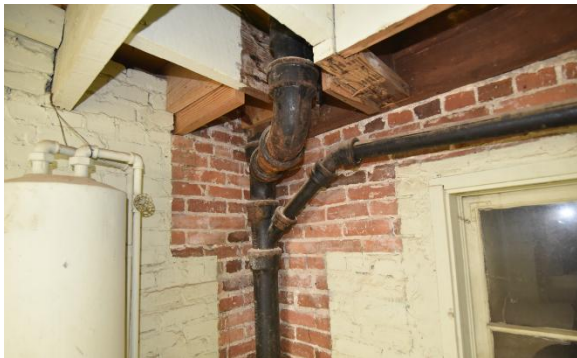
Most of the evidence of Choate's original floorplan has been altered by subsequent modifications, however, the plumbing stack for the original bathroom, now disconnected, survives in the back corner of the rear basement - a silent testament to Choate's defense of his design.

*Sec. I/ Fig. 31 The original plumbing stack below the building's first bathroom survives in the basement.*

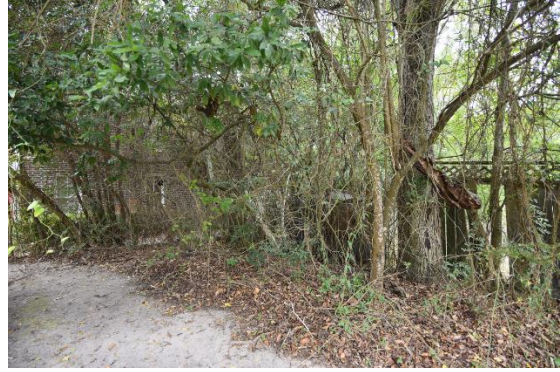
A large tangle of undergrowth and two large canopy trees crowd the extreme southwest corner of the lot.

*Sec. I/ Fig. 48 Extreme southwest corner of property is overgrown and bordered by deteriorated fence line.*

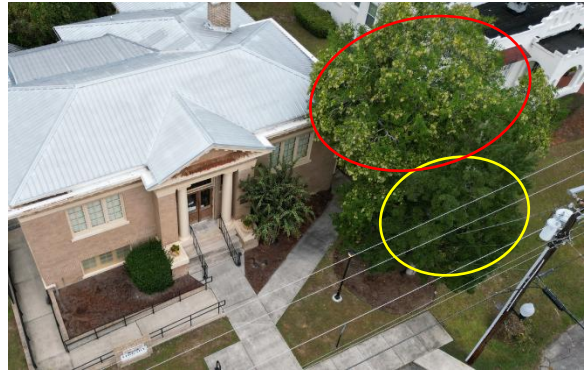
There are also two trees located near the northeast corner of the building. The smaller one (yellow circle below) is a Magnolia. The larger one (red circle) is a Glossy Privet, a common decorative planting from the mid-20<sup>th</sup> c. The Glossy Privet is now classified as an invasive species because it outcompetes native understory trees, reduces native plant diversity and alters soil chemistry. Georgia's

Sec. I/Fig. 52 Two mid-canopy trees shade the northeast corner. The larger one (red circle), a Glossy Privet, is now considered an invasive species.

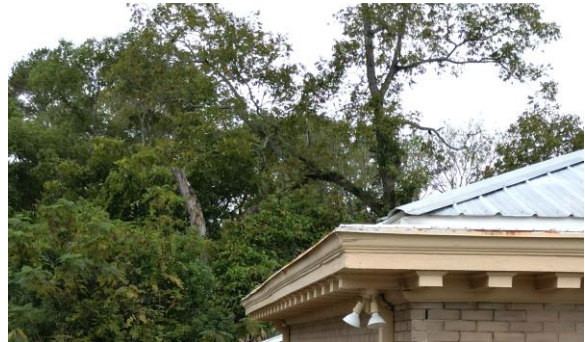
At the rear of the property, two high-canopy hardwood trees, species currently underdetermined, loom over the structure. One appears to be dead and is threatening the building should it fall.

Sec. I/Fig. 53 Two trees in the building rear are threatening the structure.

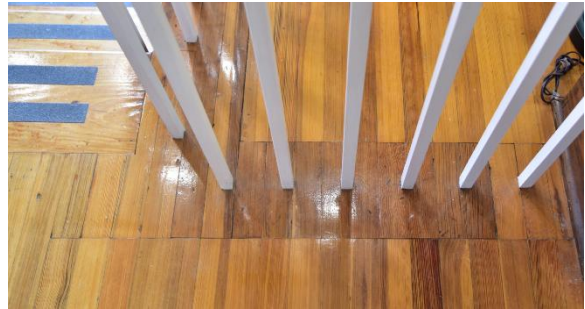
The outline of these old walls is still visible in the flooring despite tightly executed patching.

Sec. I/ Fig. 55 Discoloration of flooring shows original wall location.

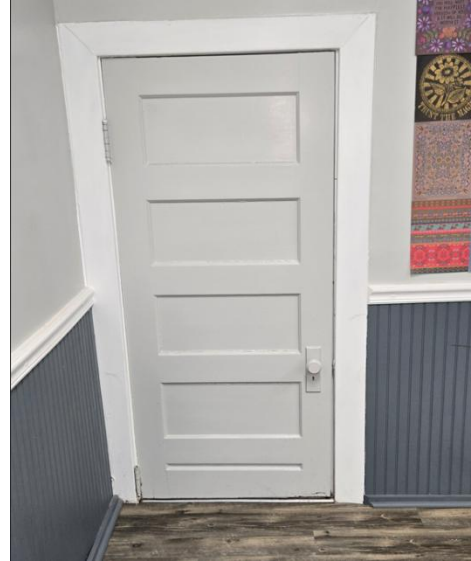
It also appears the entire southside basement floor, in the function room, was raised several inches – perhaps to bring it level with the bottom of the ADA ramp and doorway on the exterior. The narrow width of the

*Sec. I/ Fig. 58 Narrow width of bottom door rail strongly suggests floor height was raised during the remodeling.*

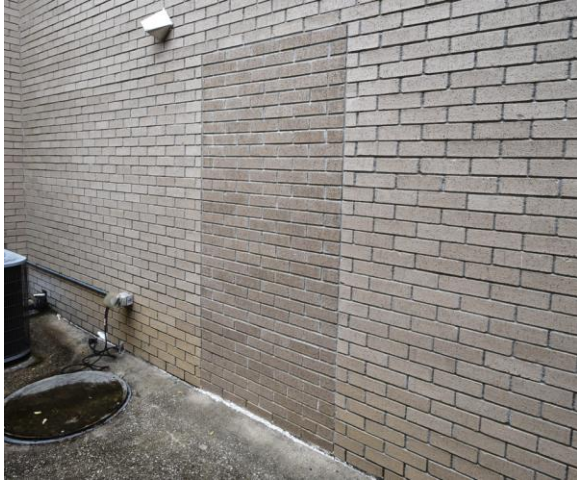
When the 1993 Addition was constructed, a new basement egress was added in the southwest corner. This replaced the historic basement exit in the northwest corner. When the ADA Ramp and Doorway were added in the

*Sec. I/ Fig. 61 The 1993 rear exit was in-filled during the ADA ramp addition.*

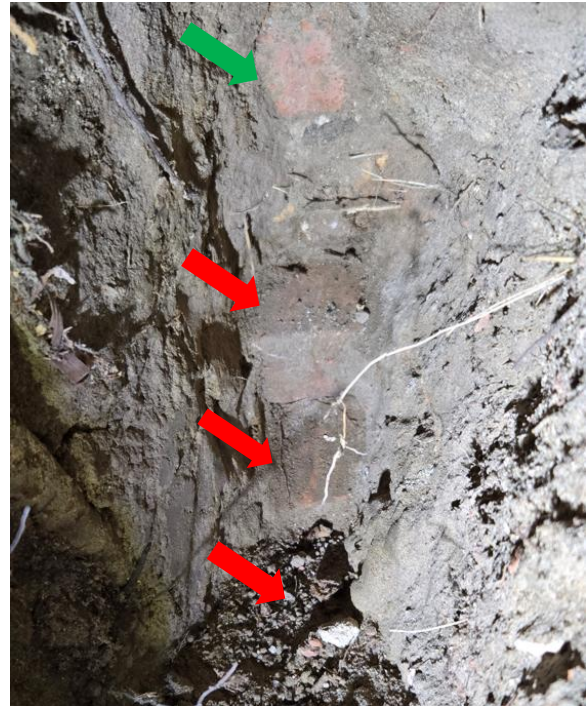
Site excavations indicate the strip foundation for this building is composed of at least three brick courses arranged in a batter configuration (each course steps outward as it descends). It is possible additional courses maybe found with more excavation.

*Fig.II.2 Excavation shows spread footer has three foundational courses below wall plane (green arrow).*

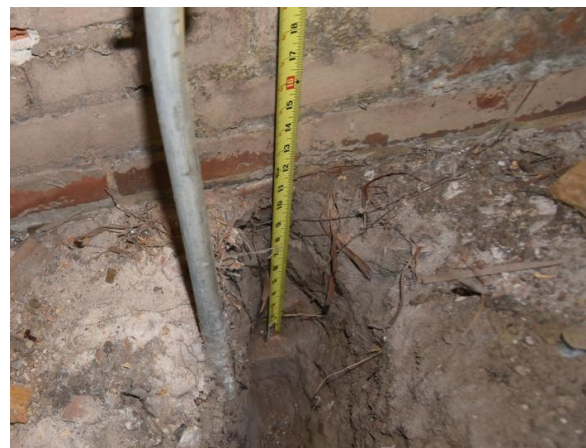
The foundation is located at varying depths below grade due to the slope of the overall site. At the rear of the historic building in the middle of the western wall, (now contained beneath the addition), the footing starts approximately 12" below grade.

*Fig.II.3 The building's spread footer is at varying depths below grade. At rear, footer is 12" deep.*

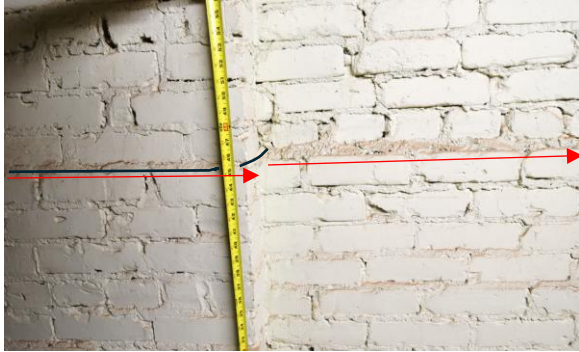
There is some indication that the masons constructed a skirt wall as a component of the foundation before erecting the full height walls upon it. Note the slight ledge

Fig.II.4 Note the slight shelf in the foundation wall. May represent the top of a skirt wall.

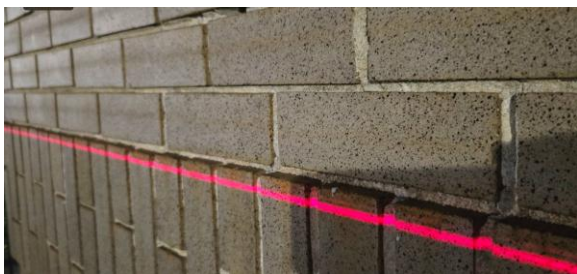
A laser level test was conducted on the exterior water table of the building. Although this is not a precise measurement, the consistent reveal of the red laser line against the line of bricks strongly suggests the building is still remarkably level. From these observations, one can conclude that the spread foundation of the historic building is generally in sound condition.

*Fig.II.8 Laser suggests building is still remarkably level.*

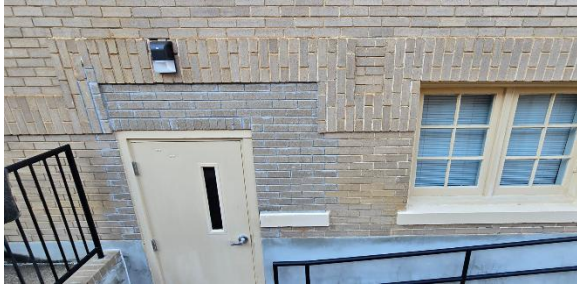
**Modifications:** The exterior walls of the historic structure are largely intact with one significant exception. When the ADA Ramp and doorway were added, a window bay was converted and in-filled. The historic water

table and a portion of the limestone windowsill were preserved.

*Fig.II.30 An historic basement window on the south elevation was converted into an ADA compliant doorway.*

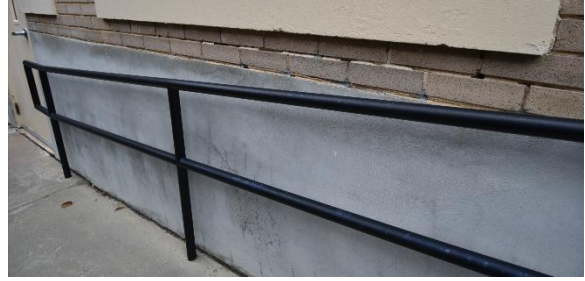
Another component of this ADA ramp project was the application of a concrete rendering (coating) on the lower portion of the exposed exterior wall.

*Fig.II.32 Lower portion of wall covered with skim coat of concrete.*

This was likely done to provide some protection again rising moisture splashing up off the ramp but also to mask the common red bricks which the original builders used for the exterior walls below grade. The use of red brick at grade is still visible just above the sidewalk on the north side of the building.

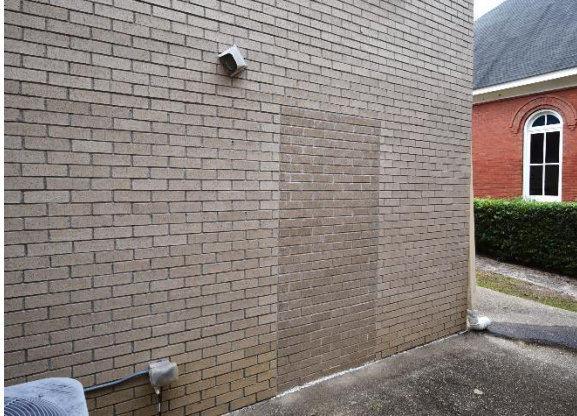
Another more recent modification was the closing of a ground level doorway on the west side. This was done sometime after 1993 when this portion of the building was constructed. Note the different color bricks used for infill.

*Fig.II. 34 In-fill of basement doorway on west elevation. Exact date unknown.*

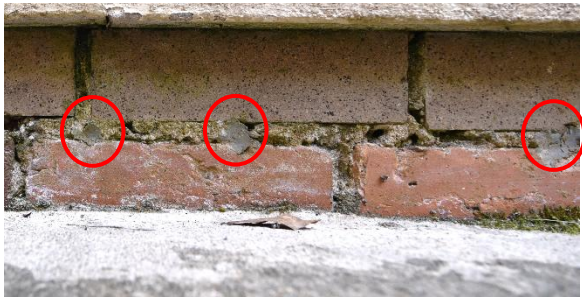
One further modification is the apparent patching of the weep holes in the historic foundation. Weep holes are small openings intentionally left or created in the bottom course of masonry walls or foundation walls that allow trapped water to escape from behind or within the wall system. They serve as a controlled drainage point, relieving hydrostatic pressure and preventing moisture accumulation inside the wall. At some point before the 1993 Remodel, all the holes around the building were patched.

*Fig.II.35 Weep holes in historic exterior walls patched.*

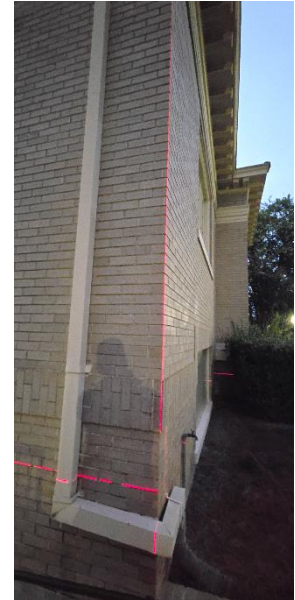
The exterior walls of the historic building are structurally sound. There is no evidence of significant foundational settling or wall deflection - meaning the building is still relatively plumb (straight up and down) and the walls are not bulging inward or outward. Note how true the laser line runs on the southeast corner of the building. This indicates the corner is still plumb which would not be the case

*Fig.II.36 Laser tests indicate exterior walls are still relatively level and plumb.*

if the building had settled. Similar results were observed at the southwest and northeast corners of the building. Additional tests at the midpoints of the north and south walls indicate relatively insignificant wall deflection (bowing). A laser test on the north wall revealed a slight outward tilt at the top of the wall of  $\frac{1}{4}$ " over 17'. A similar test on the south wall showed an inward tilt of  $\frac{3}{4}$ ".

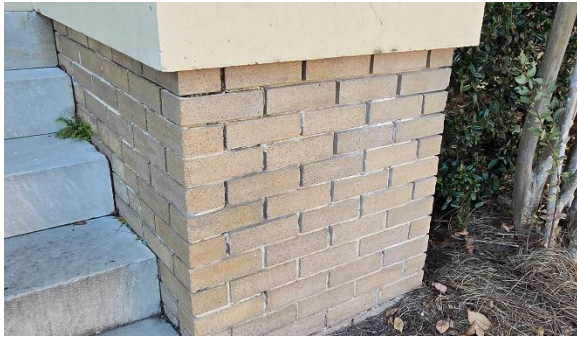
② While the structural integrity of the exterior walls is good, there are numerous places where long term moisture invasion has caused damage to the historic brick and mortar. The most widespread problem is mortar recession – meaning the retreat or disappearance of a sound mortar joint between the bricks.

*Fig.II.38 Southeast corner of northern cheek wall at entry*

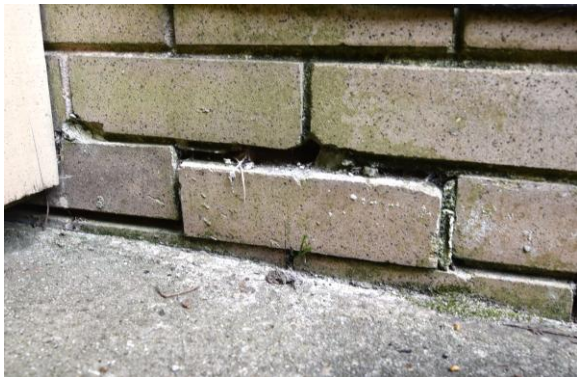
In some cases, the combination of this moisture exposure and the effects of the freeze/thaw cycle has dislocated individual bricks, caused fractures to others or degraded the brick in a condition known as spalling.

*Fig.II.39 Dislocated brick on north elevation at grade due to water invasion and freeze/thaw cycle.*

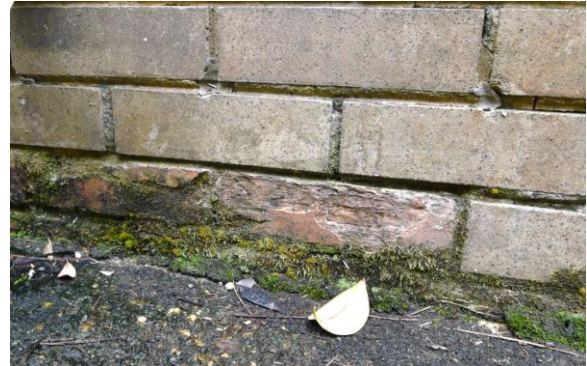
*Fig.II.41 Spalling brick at grade on north elevation.*

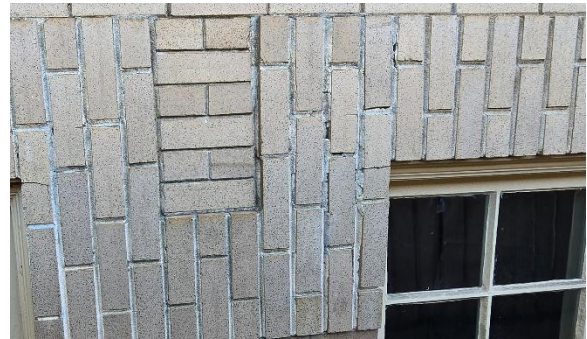
*Fig.II.42 Failing mortar joints and material separation in water table on north elevation. Note: this may be related to the cracks on the interior walls along this same window.*

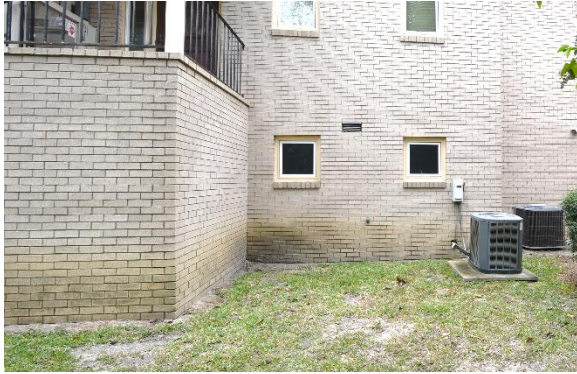
3 On various section of the building there is significant evidence of organic staining due to rising moisture.

*Fig.II.43 Lower wall staining due to moisture splashing back onto building during rain events.*

This happens when rainfall splashes upward onto the masonry surface and then does not evaporate. This is limited to the lower two feet of the wall surface and is most prevalent on the northern and western walls – two areas with limited sunlight exposure and no drainage system on the roof above.

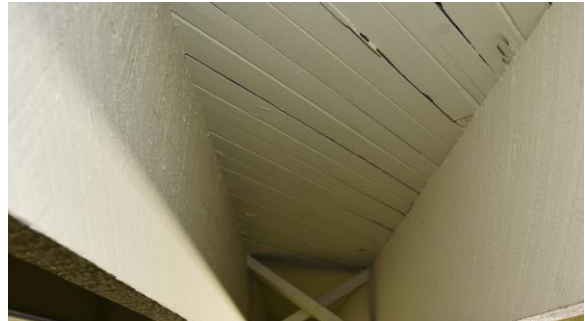
The wood floor framing system is in good condition. The joists show no evidence of rolling (leaning) or checking (longitudinal cracks due to stress). The subfloor is still well attached to the joists although some separation of the tongue and groove seams was observed.

Fig.II.52 T&G subfloor still well fastened to joists.

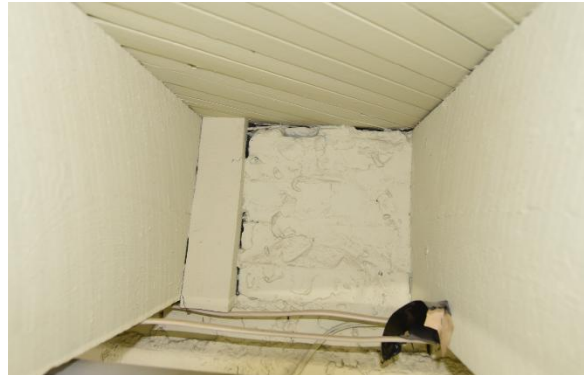
Many of the observed joist pockets are still tight and well seated.

Fig.II.53 Joist pockets have good integrity.

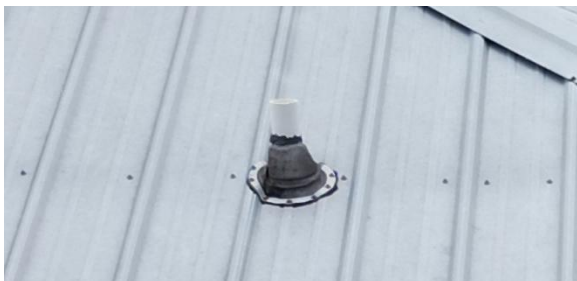
The roof has two penetrations. One is a plumbing vent on the west side which is well flashed with a rubber boot.

*Fig.II.70 Plumbing vent penetration on west side is well flashed and sealed*

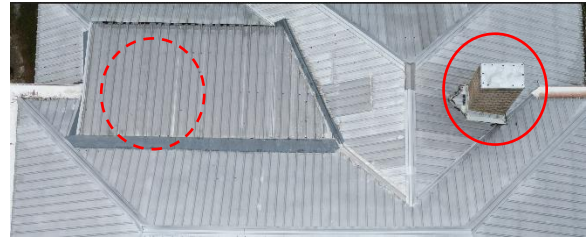
*Fig.II.71 North side chimney survives. South side (red circle) was likely removed during 1990s addition project.*

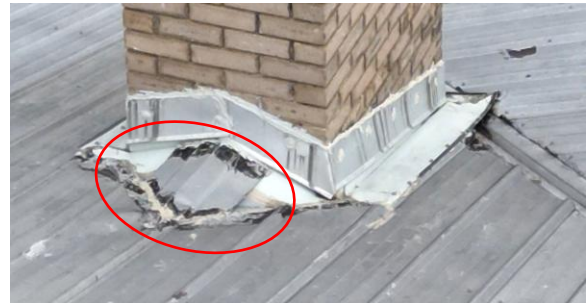
The apron flashing around the chimney appears sound but the high side cricket flashing may have leaked in the past as evidence of a subsequent patching is visible.

*Fig.II.72 The cricket appears to have been patched several times after installation.*

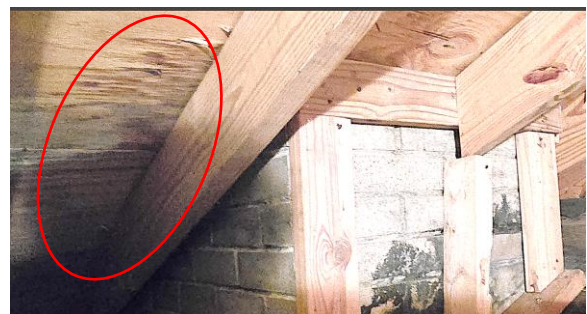
A visual inspection of the area below this cricket suggests that leaks were a problem in the past but are not currently active. No elevated moisture readings were noted here.

*Fig.II. 73 Area below and adjacent to chimney cricket is currently dry but appears to have leaked in the past (red circle).*

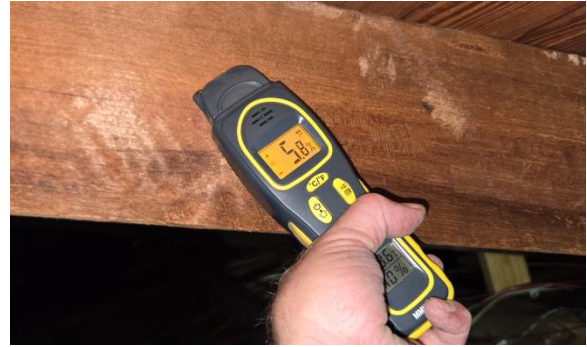
The roof system is in good condition although some questions are noted below. There is evidence of moisture stains on several rafters and some roof decking, but these appear be dormant. Spot checks indicate many areas are currently dry registering a comfortable 5% to 6% moisture content level.

*Fig.II.75 Spot checks revealed acceptable moisture content readings throughout the attic.*

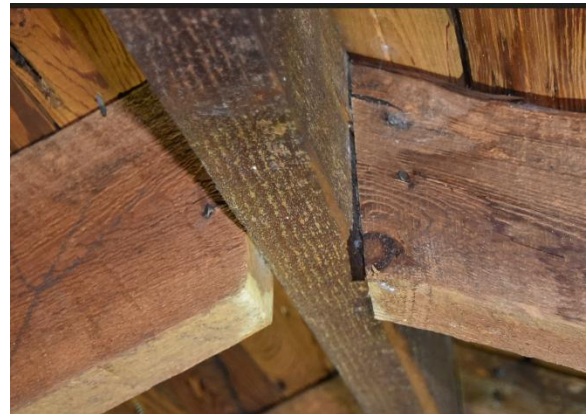
The rafters/ridge beam joints show minimal separation.

*Fig.II.76 Rafter/ridge beam joint show minimal separation.*

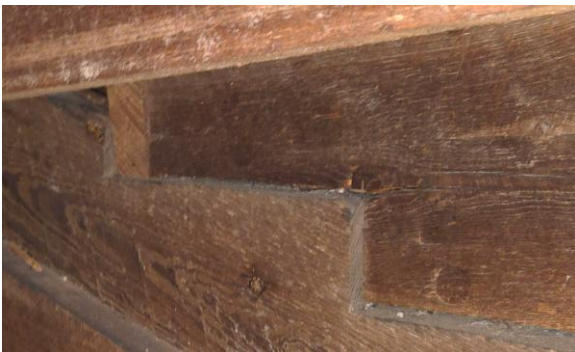
The double stop notch at the heel appears to still be well seated but it was hard to access for a close inspection. It does appear to have shifted.

*Fig.II. 78 The double notched heel joint appears well seated but may have shifted. Close inspection was difficult.*

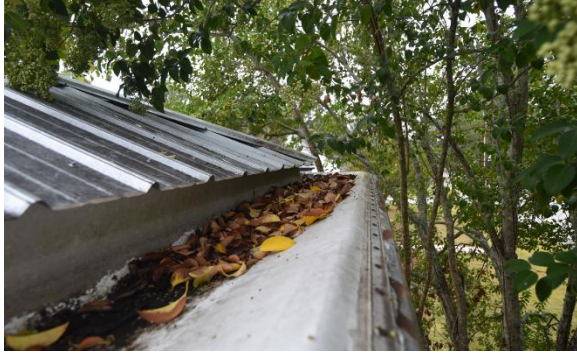
① The upper elements of the drainage system are working well although several gutter sections need cleaning. There is significant accumulated organic debris in both the southwest side K gutter and the northeast corner box gutter.

*Fig.II.90 Upper elements of the drainage system need cleaning but are otherwise sound and operational.*

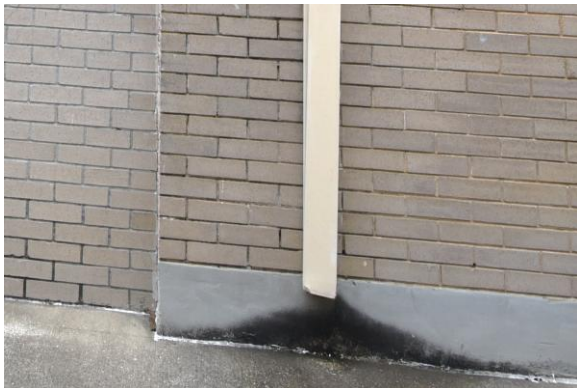
- 1 The elbow on the south side downspout is missing which is resulting in a concentration of water on the concrete apron and lower wall.

*Fig.II. 91 Missing elbow and poor water drainage are undermining the concrete apron on the southwest corner of the building.*

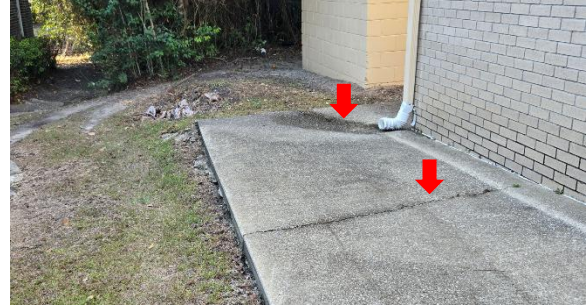
Water, both above and below the concrete, combined with another downspout 12' away, is working to erode the soil at this corner of the building and undermine the sidewalk. Note the two cracks which cross the entire concrete slab. At present, this erosion does not appear to be causing any damage to the foundation, only the apron, but this should be monitored.

*Fig.II.92 Poor drainage has undermined the concrete apron resulting in two full failures (red arrows) of the concrete slab.*

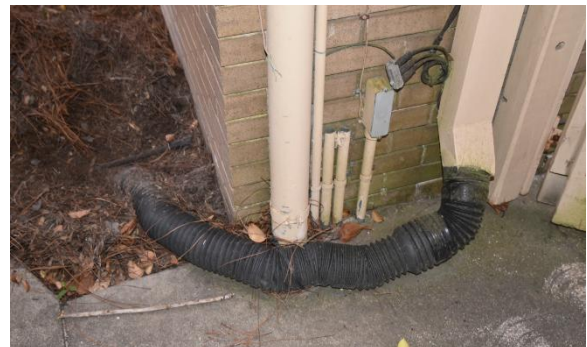
On the north end, water from the downspout is emptied into a small patch of soil in front of the basement window.

*Fig.II.93 At the northeast corner, the ground drain directs water into small yard area lacking effective drainage.*

For light rainfall, this is probably adequate but for heavy storms which are increasingly frequent, the water is likely pooling in the far corner against the wall and seeping inward. The sidewalk and slope are preventing the water from moving away from the building.

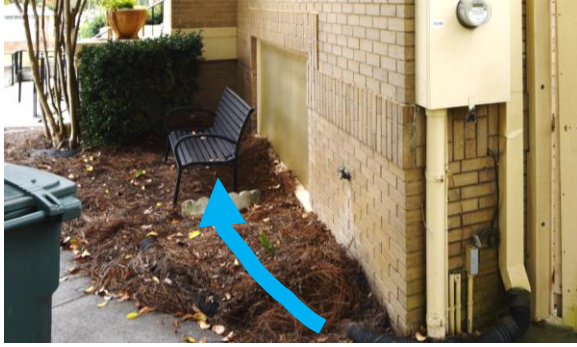
*Fig.II. 94 Rainwater runoff is flowing down the slope toward the main entry wall and becoming trapped against the building.*

On the interior of the building adjacent to this area, several bricks show evidence of spalling which is caused by excessive moisture in the bricks. A digital reading of these bricks shows a high moisture percentage (17.9%) for an interior location and strongly suggests the water has worked its way inward and continues to do so.

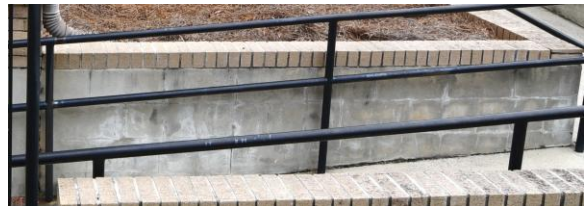
The presence of the white calcification lines on the outside of the retaining wall, known as efflorescence, is caused by salts accumulating when moisture evaporates. This is clear proof that excessive exposure to water is straining this masonry element.

*Fig.II.97 The white lines along the mortar are evidence of excessive moisture seeking a "way out."*

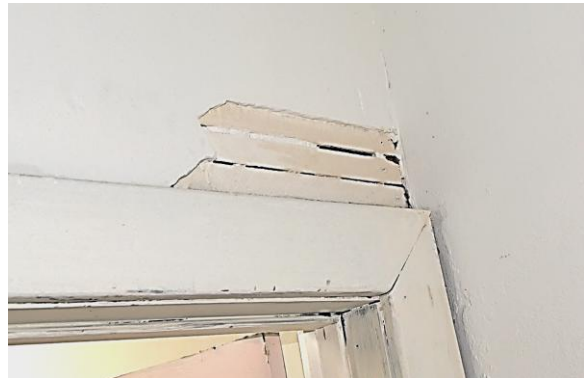
*Fig.II.104 A damaged section of closet interior wall in the basement shows the wood lath that underlies the plaster.*

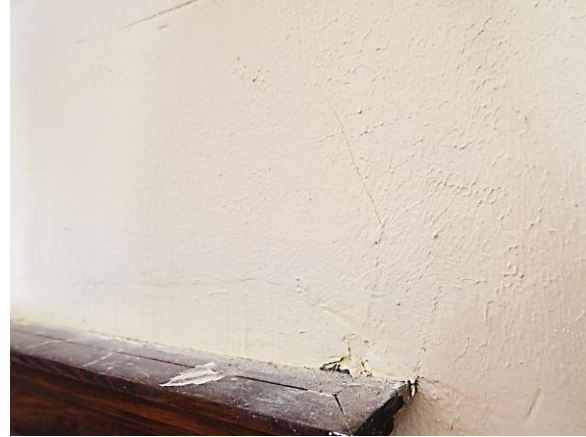
Except for the four issues detailed below, the walls of the building, particularly the plaster on brick sections on the first floor, are in amazing condition. This is a testament to the care the building has received over the last 100 years. Where one would expect to see diagonal cracks or plaster separation due to load shifting or water invasion, the interior finish is firm and intact. On the first floor, only one hairline crack was observed in the front wall over the southeast window. There are likely others but all would be small and almost invisible. This crack should be periodically monitored to determine if it is active.

Fig.II.107 The plaster on brick walls, on the first story, are in excellent condition with only minor cracks observed.

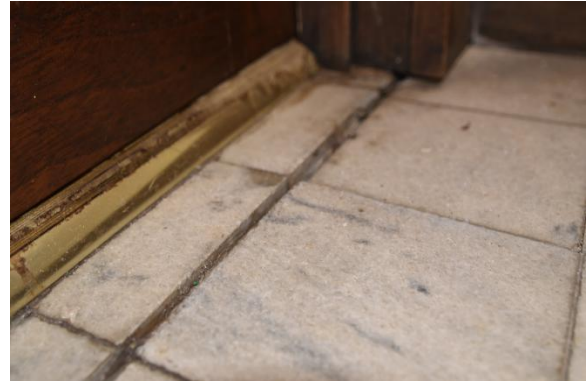
This water flows inward beneath the threshold and collects on the floor inside the entry.

*Fig.II.111 Water flows under threshold, collects inside and drains into wall cavity below.*

Note the water stains, settling and damaged grout in this corner. From here, the water seeps downward onto the brick below and into the interior wall cavity. During inspection, the moisture reading on the inside wall in the basement was low, but this was likely due to the lack of recent rainfall.

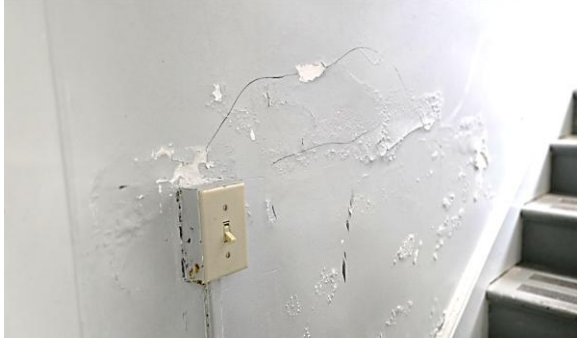
The second area of concern is along the stairway wall to the basement. An active source of moisture is damaging the plaster finish here causing it to separate from the brick. The cracks and blisters indicate the problem is widespread along this section of the wall. Multiple moisture readings revealed a mix of high rating between 13.4% and 17.7% - very high for an interior wall such as this.

*Fig.II.112 Extensive water damage to interior plaster finish in stairway.*

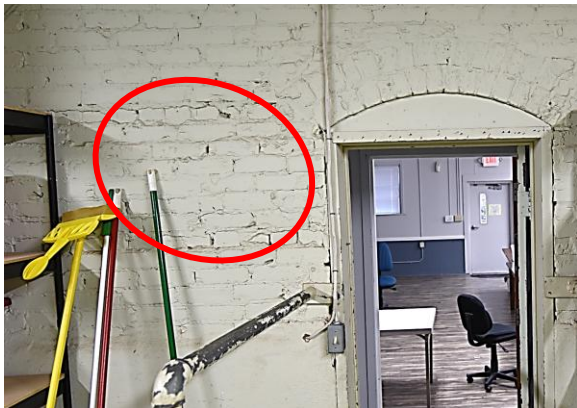
① The source of this moisture has not been fully determined. The damage is not located below any known plumbing line nor is there any evidence that water has flowed downward from the attic/roof. Additionally, the reverse side of this brick wall does not show any indication of similar water invasion.

*Fig.II.113 Reverse side of damaged stairway wall shows no evidence of water invasion.*

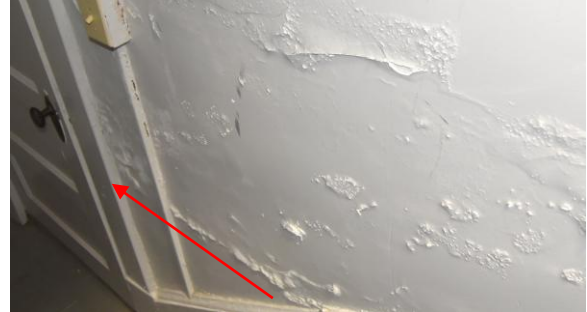
The most likely explanation for the source of this water is the pooling rainwater on the northeast exterior described in the drainage section of this report. While this water is some distance away, over 8', the low placement of these "bubbles" combined with the fact that at least one of them show a very pronounced horizontal configuration, strongly suggest the water has flowed along mortar joints in the brick wall, possibly from the exterior. This is speculative and only destructive plaster removal will provide a positive explanation.

*Fig.II.114 Note how the damage is spotty and in the lowest area, (red line) very horizontal. This may indicate the water is flowing along the internal mortar joints.*

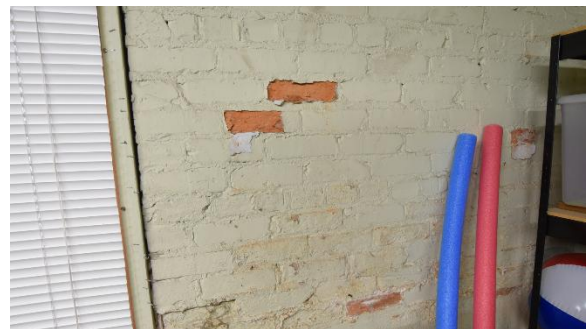
① The third area of water damage in the basement is along the east wall of the storage room. As noted in the Drainage Section of this report, water from a poorly channeled downspout on the northeast corner of the building is creating a destructive level of moisture below grade. This moisture is being absorbed by the brick and migrating inward toward the interior. The spalling bricks are evidence that the problem is chronic and long-term. Moisture readings on the brick registered 17.9%

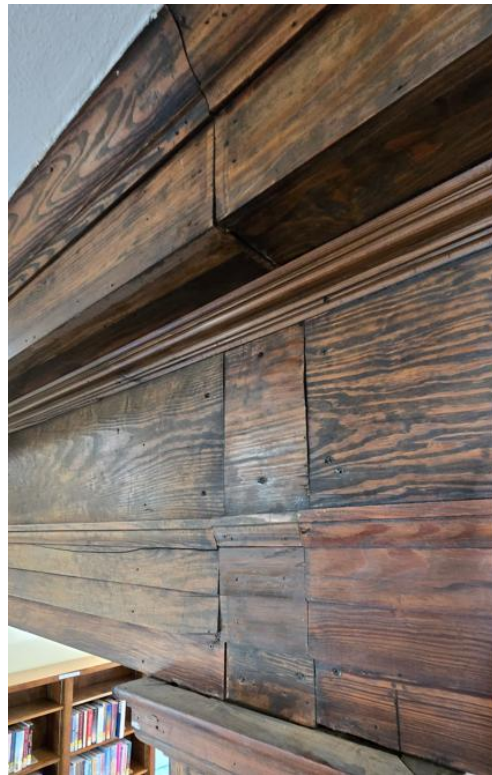
On the southside beam, there is significant evidence of repairs and reconstruction where the stairway wall was removed. The wall pocket has been patched and several of the trim pieces have been replaced. There is a possibility the entire column was reconstructed but this was not confirmed.

*Fig.II.135 Southside beam shows extensive patching at old wall seam.*

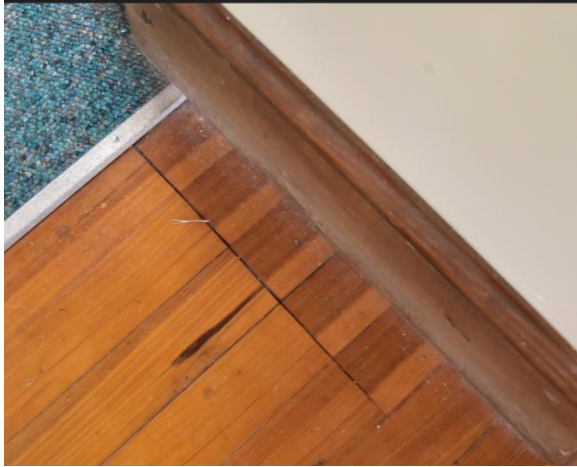
The other three pillar were removed possibly as a part of the 1990s renovation. The outline of the removed pillars is still visible behind the circulation desk where the flooring was patched.

*Fig.II.140 Floor patch indicates original footprint of half pillar along wall.*

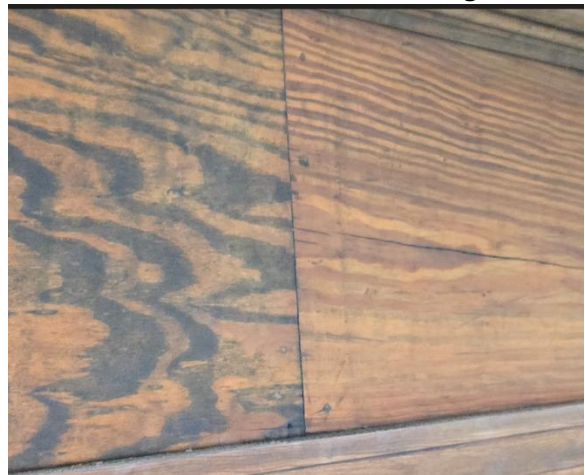
Additionally, perhaps due to the width of the main center board in the beam which is a ½" larger than standard available dimensions, the wood repair was made with plywood versus an actual wood plank. Note the dramatic difference in grain pattern at the seam. The modern wood, on the left, is a poor match for the historic wood on the right.

*Fig.II.156 The wood on left is likely plywood made to look like the historic plank on the right.*

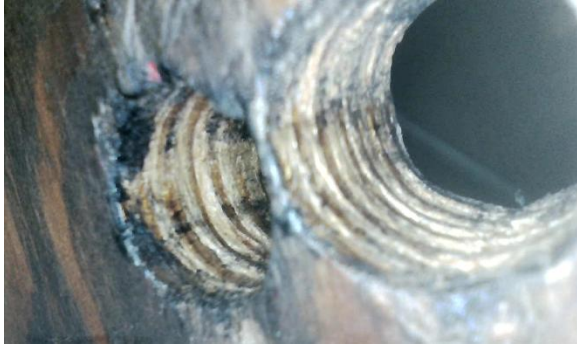
Plywood may have also been used to reconstruct some or part of the north pillars. Two existing holes show a suspiciously regular growth ring pattern which strongly suggest the layers used in plywood manufacturing.

*Fig.II.157 The regular ring pattern on the inside of these holes strongly suggests the separate layers of plywood versus actual wood.*

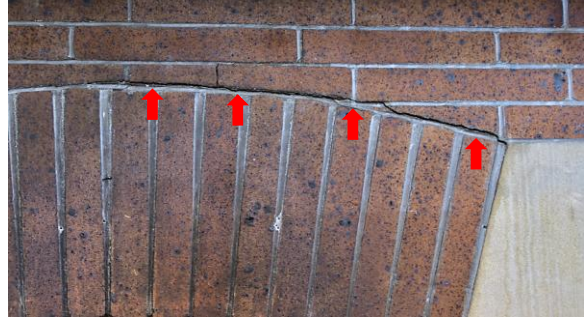
This same water has damaged the mortar above the right side of the segmented arch. The source of the water was probably a leak in the flashing way up at the roof line. This does not appear to be an active leak.

*Fig.II. 159 Mortar failure above segmented arch on north fireplace.*

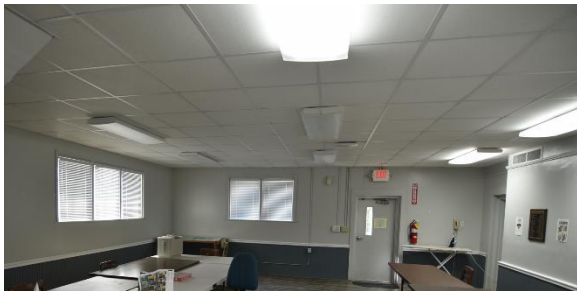
In the basement, the original ceiling, which is intact plaster on lath, has been obscured with a suspended or drop ceiling composed of acoustic panels. This was almost certainly done to facilitate the installation and wiring of upgraded overhead lighting.

*Fig.II.162 The acoustic ceiling in basement function room obscures the original plaster finish which is still intact.*

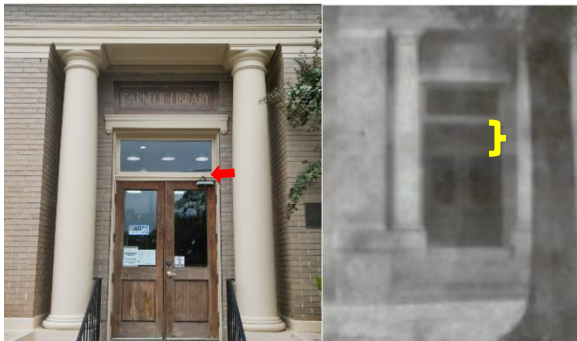
These doors are old, possibly more than 50 years, but they are not original to the building or not original to this opening. While their two-panel design is consistent with a historic photograph showing the building in its earliest decade, the distance between the transom window above - and glass panels below is far greater in the historic photographic (yellow ellipse) than in the contemporary photograph (red arrow).

*Fig.II.166 There is a significant dimensional difference above the glass panel in the historic photo versus the same*

*area in a contemporary image. This suggests the present doors are not original.*

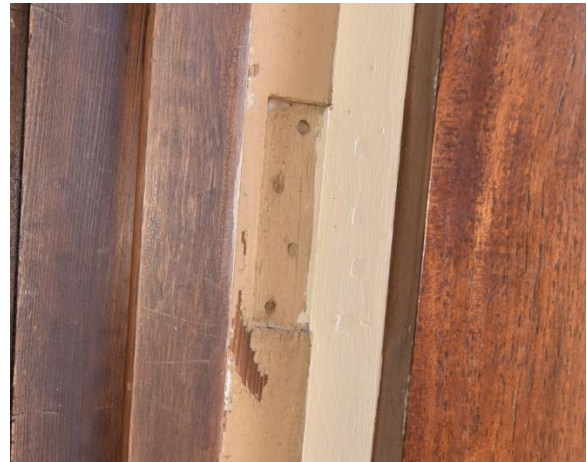
Furthermore, examining the hinge jamb on the right side shows the overpainted mortise of an earlier hinge mount. There is evidence of another mortise further down the jamb. This strongly suggests that an earlier door/hinge configuration occupied this opening.

*Fig.II.167 An earlier hinge mortise is visible in the jamb indicating a prior door mounting.*

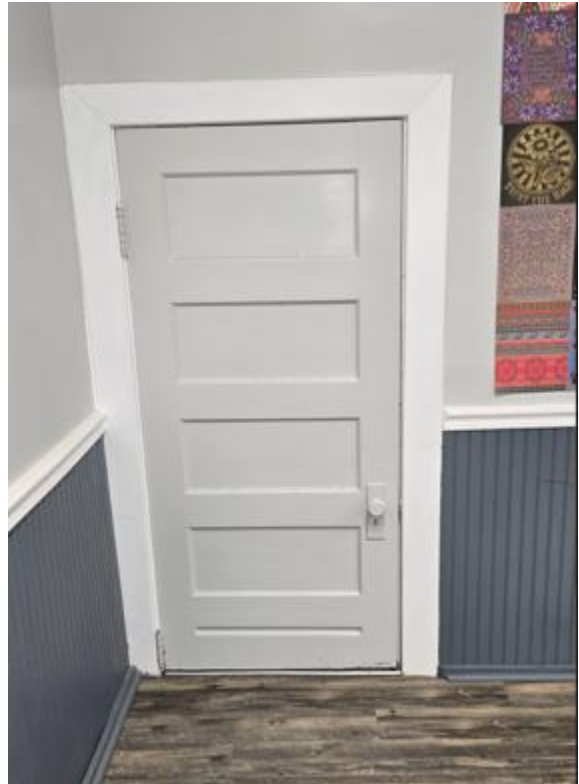
Both doors are less than 63" in height which strongly suggests they were cut down and modified when the floor was raised in this room. Both were once probably the five panel design seen on the storage room door. Like that door, both hang from sets of 4" hinges.

*Fig.II.180 Note how door has been dramatically shortened at the bottom. A strong indication that the floor was raised from original height and doors cut down to fit.*

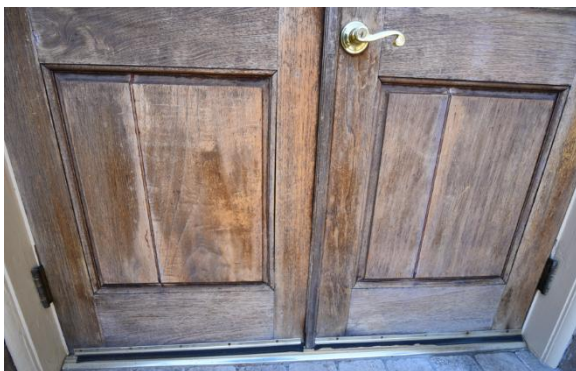
② The historic doors are in fair condition which means they are intact but are showing decay or damage. The finish on the exterior of the main entry doors has degraded.

Fig.II.182 Finish on exterior of main doors has degraded and needs restoration.

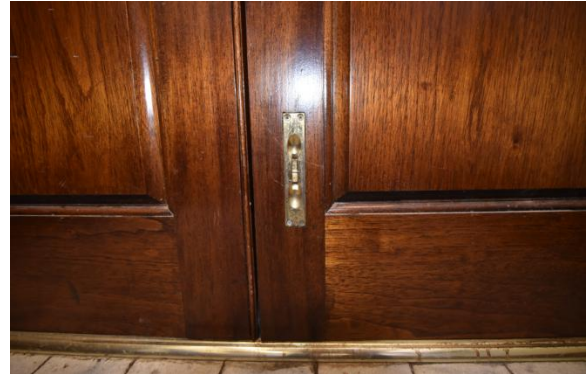
The flush bolt at the bottom of the south main entry door is not operational. At present, the

lever pinion will not lift, and the door cannot be opened.

Fig.II.183 Lever on interior of main door is not operational.

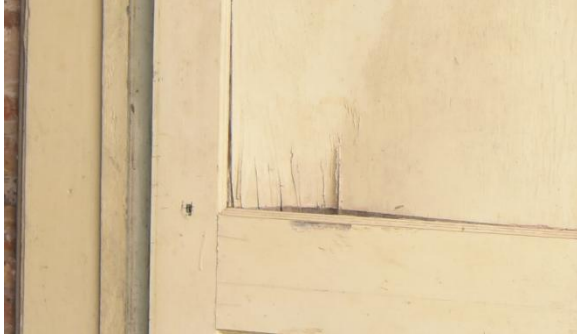
The old basement exterior exit door has a broken upper panel that needs repair.

*Fig.II.185 Broken upper panel on historic basement exit door.*

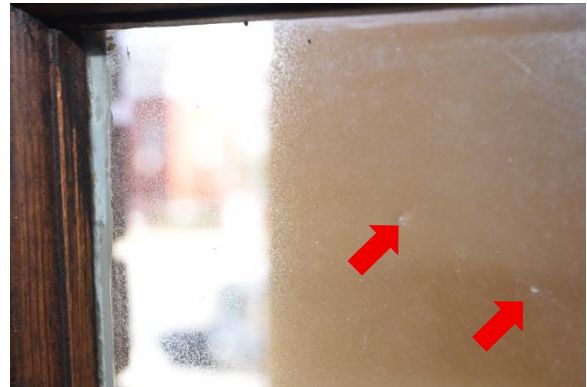
*Fig.II.195 Some of the glass shows signs of its early manufacturing process. Note the pits in this entry window.*

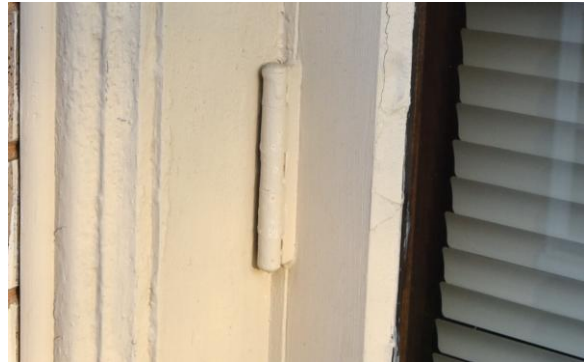
The historic windows are in good condition meaning their structural integrity and weather sealing functions are sound. However, they do need specific types of maintenance and care. With the exception of the three windows entombed in the back basement, none of the historic windows are presently operational.

This is due to multiple paintings of the seams and hinges.

*Fig.II.204 The windows are not operational due to overpainting of seams and hinges.*

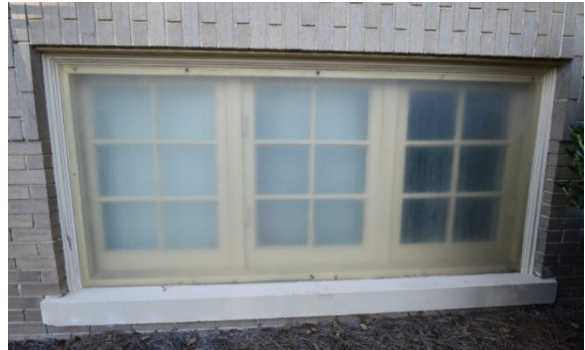
It should be noted that the basement window on the front (east) elevation were inaccessible (on the exterior) due to the plexiglass storm coverings.

*Fig.II.205 Plexiglass storm windows made front basement windows inaccessible for inspection.*

② These plastic storm windows can be beneficial for stopping chronic moisture exposure but they also pose risks as water can be trapped inside the void between the window and the plastic cover. Additionally, they negatively impact the historic character of the building.

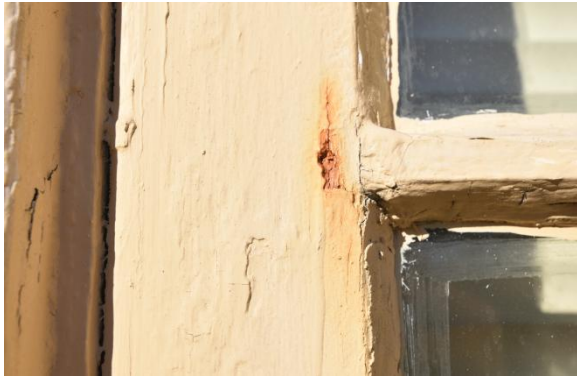
The structural integrity of the windows is remarkably good. Very little material deterioration or decay was observed on either the interior or exterior sashes or frames. The muntins are also sound and firm on the interior but rust jacking (where an iron residue from a nail or fastener bleeds through a finish)

was observed on many of the exteriors where the muntin is attached to the stile.

*Fig.II.206 The window elements have good integrity but rust jacking was noted on several. Note the reddish stain where the muntin meets the stile.*

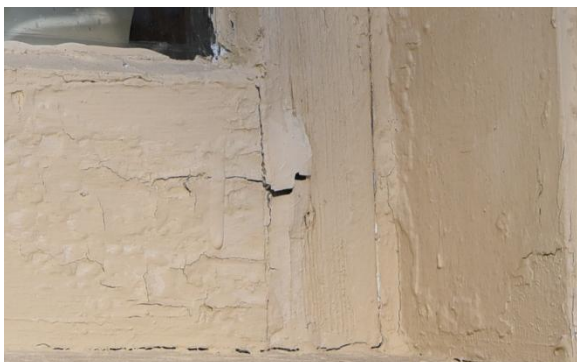
2 Many of the windows are showing failure to their painted finish. It is not yet severe but there were numerous instances where the paint is chipping, alleagoting or flaking.

*Fig.II.208 Several windows exhibited large chips or flaking.*

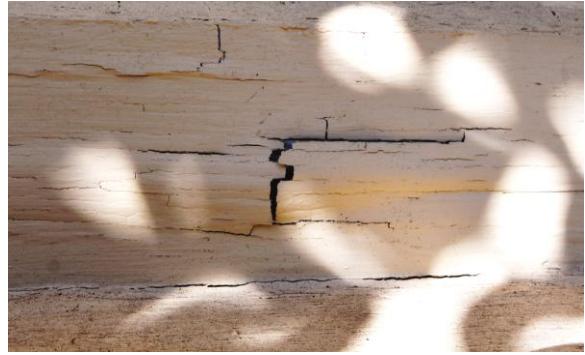
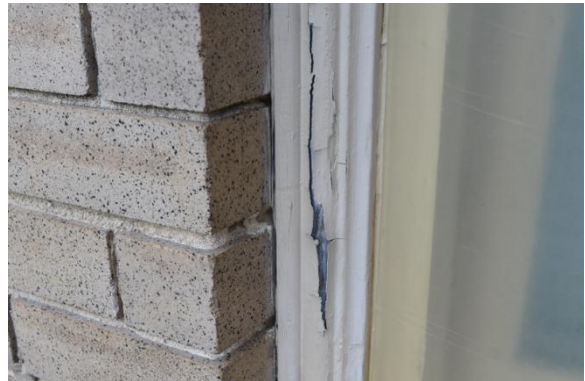
*Fig.II.209 Some of the damaged areas are exposing the wood below which will lead to rot and deterioration.*

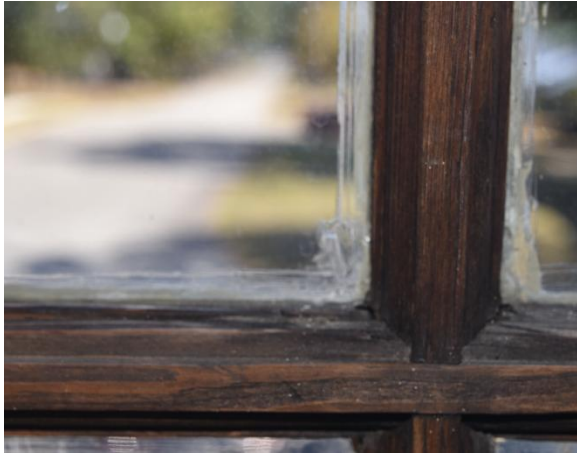
On the interior, many of the windows show sloppily applied silicone caulk which may have been used to seal gaps.

*Fig.II.211 Silicone chalk was applied to the interior on many of the windows.*

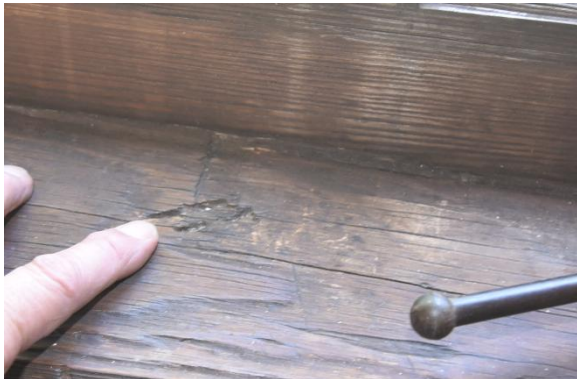
The wood finish on the interior is old and, under close examination, shows some fading, marks of past water invasion, cracking and material separation.

*Fig.II.212 Some of the interior wood elements show past damage from water or sun.*

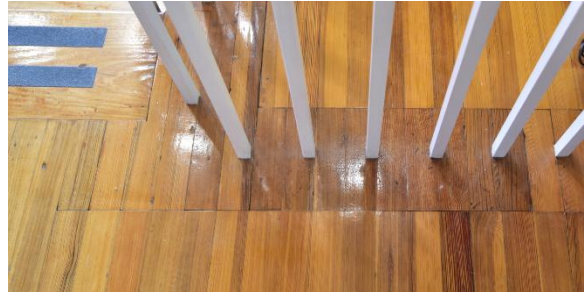
The floor in the public area has been refinished (sanded) several times. It has also been patched in several places, most significantly at the top of the main entry stairs where an interior wall once stood.

*Fig.II.218 Patching where entry stairway wall once stood.*

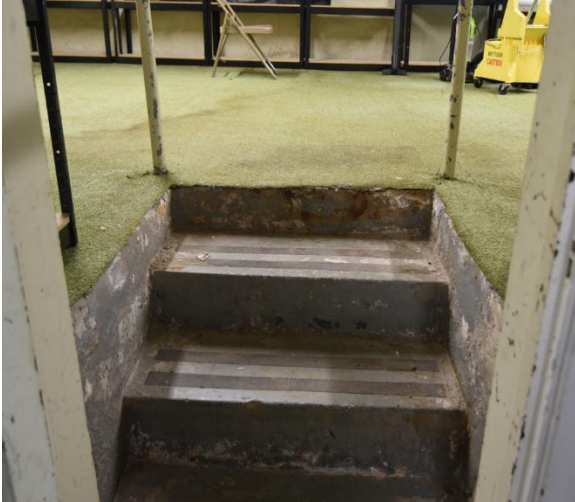
In the storage room, green indoor/outdoor plastic carpeting covers an original, poured concrete slab floor. The thickness of this slab could not be determined during inspection. It is considerably higher (23") than the adjacent stairwell wood floor and even higher than the southside function room which was actually raised when the room was refurbished in 2015. This difference in the floor elevation across the basement is presently an unsolved mystery.

*Fig.II. 225 The thickness of the raised concrete floor on the northside basement could not be determined.*

One possible explanation is the that builders did not remove all the dirt excavated for the foundation in the northside room and chose instead to simply level and cover it for this non-public space. This makes some sense given how much more dirt would have been moved at this end the building, which is considerably deeper, than the south end where the grade is nearly a foot lower. A set of test holes would be the best way to determine the exact thickness of this slab.

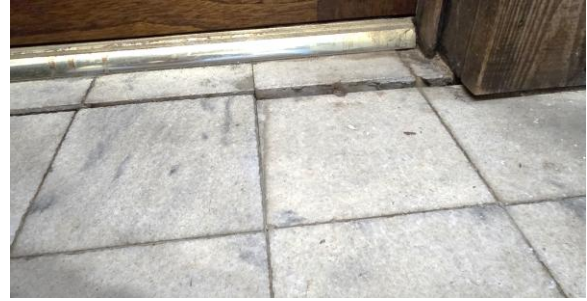
- ② The marble tile in the entry has suffered in the southeast corner due to water invasion from the stoop outside. The grout here has been extensively damaged and several tiles have settled suggesting damage to the

substrate

below.

*Fig.II.226 Note the damage grout and lowered tiles due to repeated water exposure.*

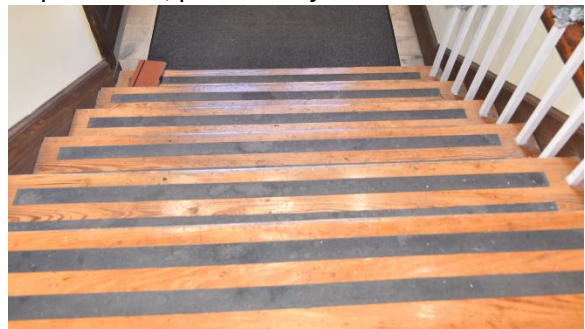
Several observations about these stairs strongly suggest they do not date from the building's construction. First and most significantly, they do not exhibit the kind of wear associated with the building's age. It would be customary to see rounded divots or depressions, particularly in the center.

*Fig.II.231 These treads do not show the appropriate wear for a building of this age.*

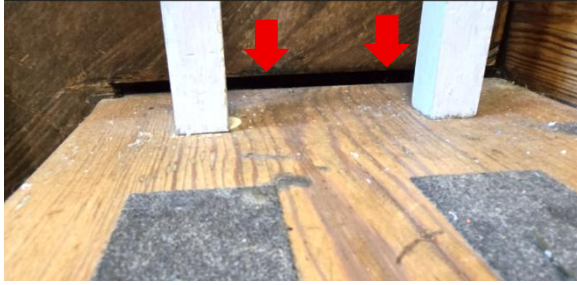
Additionally, the fit of the skirt board, on the side of the stairs, is very poor. This is not consistent with the quality of much of the original woodwork in the building. Even today this gap would not be acceptable on a public, high profile project.

*Fig.II.232 The gap (red arrows) between the skirt and the tread is not consistent with the workmanship exhibited in other historic elements.*

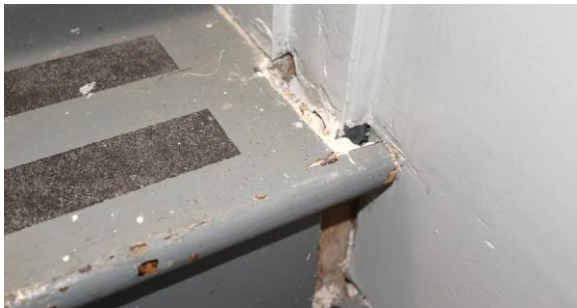
These stairs appear to be original, but some modifications were noted, particularly in the lower section. Four risers up from the bottom is evidence of a notch that may have once held a newel post. This spot aligns with the arch entry detail (noted in the interior wall section of this report).

*Fig.II.234 Evidence of a notch, perhaps for a newel post that was originally anchored at this spot.*

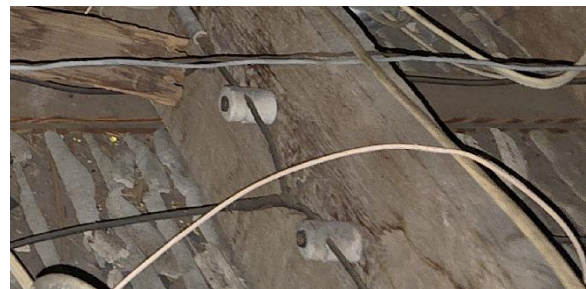
*Fig.II.236 Evidence of original knob and tube wiring is found throughout the attic.*
