# Historic Structure Report

Boston Carnegie Library  
250 South Main Street  
Boston, Thomas County, Georgia

Eric Menninger  
*EAM Preservation – Atlanta, GA*

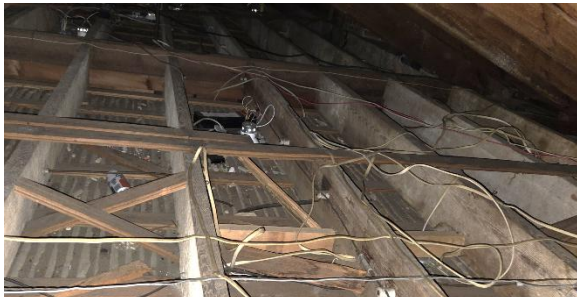
The building appears to be mostly wired with plastic coated, NM-Cable, meaning non-metallic sheathed. In the attic, many of the cable runs were haphazard and not consistently fastened to framing members.

*Fig.II.242 Cabling in attic is haphazard and inconsistently anchored.*

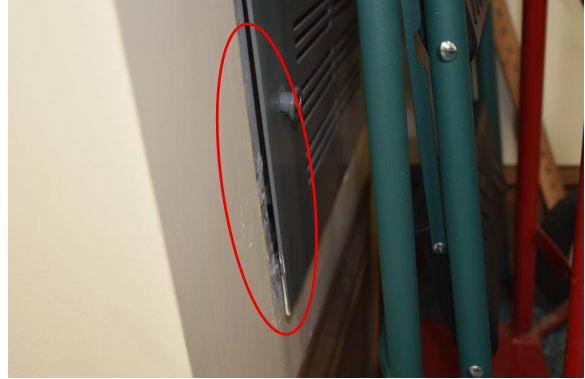
❷ It was observed that the lower left corner of the main panel cover is loose.

Fig.II.248 The lower portion of the main panel cover is loose.

The main electrical service panel in the librarian office is unsecured at the bottom. This should be properly reattached by a licensed electrician.

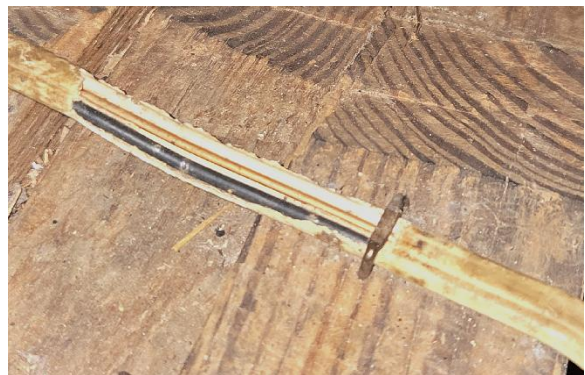
❸ Finally, in the attic there is a very worn wire that should be protected. Attached to the northern carrying beam is a section of wire that has lost its plastic coating. This piece of wire is right at the small entry to the attic so everybody who crawls through the restricted opening has put their foot on this cable. This wear has removed the other layer of protection but has not, as yet, exposed the actual copper lines. A licensed electrician will know how to remedy this risk with a minimum of effort.

Fig.II.249 A small section of plastic-coated wire, located just inside the entrance to the historic attic, has worn away.

| Rating | Recommended Treatment | Considerations | Objective | Relative cost |
|---|---|---|---|---|
| ① | Properly protect worn cable just inside crawl way to historic attic. | Could be done in conjunction with properly closing ballast junction boxes in historic attic. | Protect against accidental shorts. | \$ |

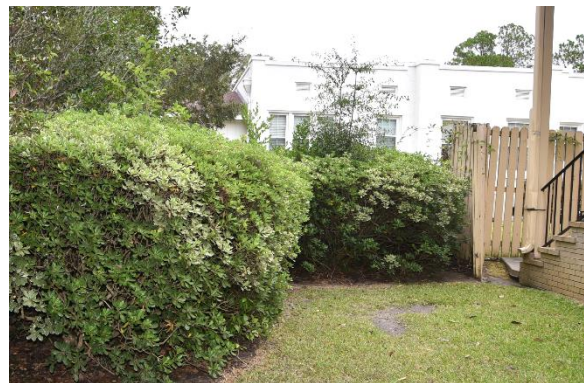
Two of the trees on the east side of the building are limiting moisture evaporation and obscuring a full view of the historic structure. The larger one, at the corner, is depositing organic debris in the roof gutter. It is strongly recommended that both these trees be removed.

*III. 1 Removal of the crape myrtle and Glossy Privet is recommended. III. 2 Removal of these shrubs would improve access.*

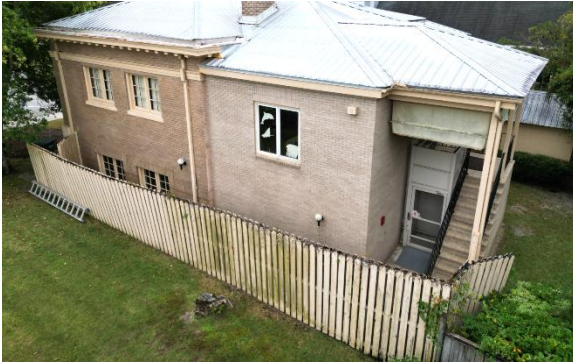
All the fence structures on the property are in poor condition and should be removed. The one on the northern boundary obscures the historic sight lines of the building and the sharp dog leg turn at the end limits access to property's rear. This may have been done to deliberately shield access to

the mechanical lift but visually this fence damages the historic character of the structure. Its permanent removal is recommended.

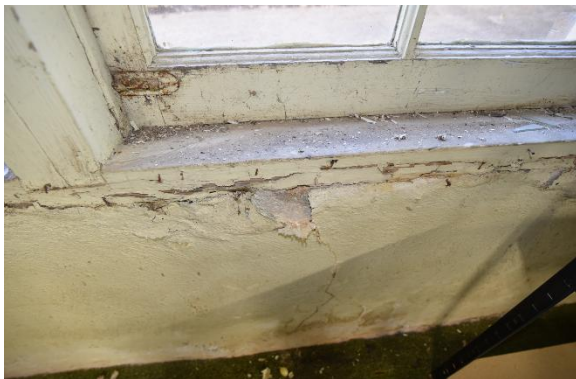
This leak needs to be checked during or immediately after a heavy rain event to determine if it is active or dormant. If active, a mason can properly seal the area with historically appropriate techniques and materials.

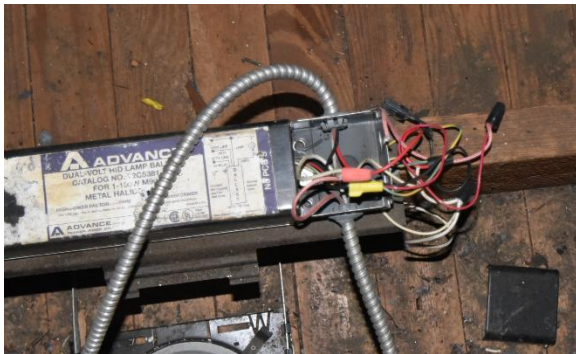
*Properly close light fixture junction boxes*

Most of the ballast junction boxes installed for the updated ceiling lighting were left open and not properly closed.

Although this is not an immediate risk, the exposed wiring here could be impacted by inquisitive squirrels who are known to chew on wire coating. Although no squirrels were observed in the attic during inspection, it is strongly recommended that all these boxes be properly packed and closed.

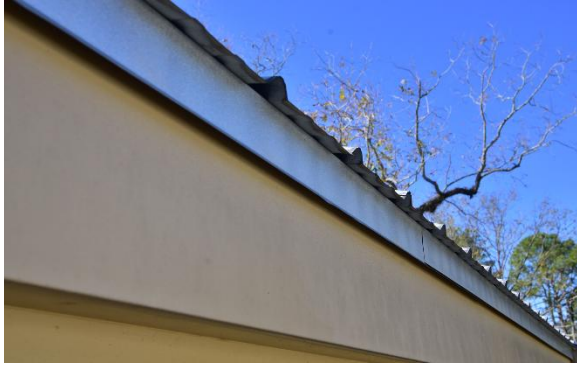
*Suggested: Install K gutters on drip edge roofs*

Install K style gutters (and downspouts) on the areas of the roof currently drained by drip edge.

This will greatly diminish the rising moisture stains on the lower portions of the masonry walls.

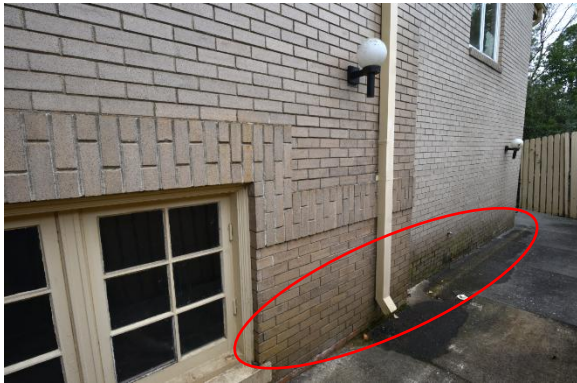
The lower portions of the exterior masonry walls, both the historic sections and the modern addition, need a cleaning to remove the accumulated organic stains. **Do not use a power washer for this task.**

Cleaning these historic buff-colored speckled bricks requires a gentle, conservation-minded approach to avoid damaging the brick surface or altering its distinctive color and texture. Buff bricks—especially early 20th-century ones—often have a softer, more porous clay body and a thin fired surface that can be easily etched, dulled, or stained by harsh chemical cleaners. The goal is always to remove harmful buildup, not to make the wall look “new,” and to preserve the natural variegation that gives the buff brick its character. The following steps are strongly encouraged.

**1. Begin With the Gentlest Method** – Using soft natural-bristle brushes and a HEPA-vacuum with soft brush attachment, do a light sweeping to remove dust, grit, and loose biological growth. This minimizes water use and avoids grinding abrasive dirt into the brick surface.

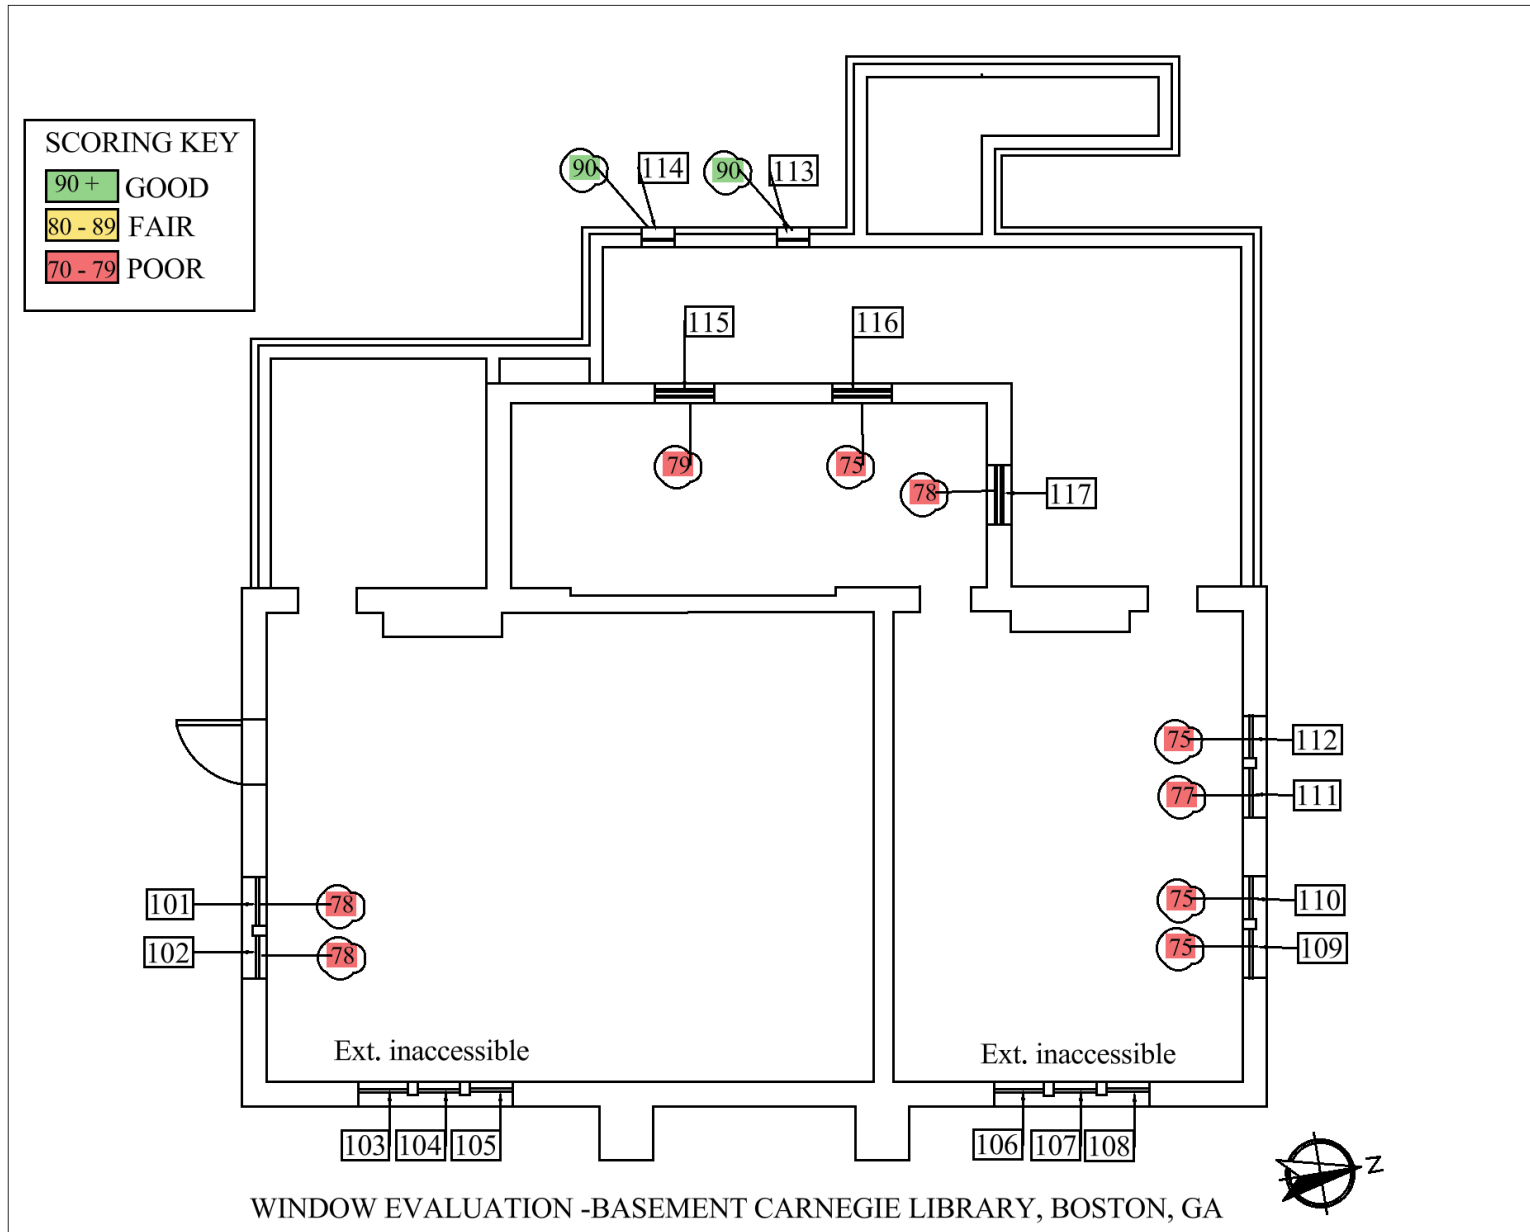
## WINDOW EVALUATION – BASEMENT

| Window ID | Historic | Adjusted Score | Raw Score | Window Type | Material | Glazing Type | Light Pattern | Hinge/Swing (looking out) | Configuration | Ext. Frame (jamb, sill, head) | Ext. Sash (rails, stiles) | Ext. Paint / Finish | Glazing putty / sealant | Glass panes | Ext. Hardware | Ext. Weather Seal | Ext. Casing | Comments |
|---|---|---|---|---|---|---|---|---|---|---|---|---|---|---|---|---|---|---|
| 101 | yes | 78 | 12 | Casement | Wood | Single Pane | 6 light | Hinged right/Out | Double | 2 - Good | 2 - Good | 1 - Sound | 2 - Good | Good | 2 - Paint encrusted | 1 - Sound | 1 - Excellent | paint decay left ext. stile |
| 103 | yes | Inaccess | | Casement | Wood | Single Pane | 6 light | Hinged right/Out | Triple | inaccessible | inaccessible | inaccessible | inaccessible | inaccessible | inaccessible | 1 - Sound | 3 - Fair | paint decay left ext. casing |
| 109 | yes | 75 | 15 | Casement | Wood | Single Pane | 6 light | Hinged right/Out | Double | 3 - Fair | 3 - Fair | 2 - Some decay | 2 - Good | Good | 1 - Sound | 1 - Sound | 2 - Good | paint decay lower rail, organic growth |
| 110 | yes | 75 | 15 | Casement | Wood | Single Pane | 6 light | Hinged left/Out | Double | 3 - Fair | 3 - Fair | 2 - Some decay | 2 - Good | Good | 1 - Sound | 1 - Sound | 2 - Good | paint decay lower rail, organic growth |
| 112 | yes | 75 | 15 | Casement | Wood | Single Pane | 6 light | Hinged left/Out | Double | 3 - Fair | 2 - Good | 1 - Sound | 3 - Fair | Good | 2 - Paint encrusted | 1 - Sound | 2 - Good | replaced pane, organic growth |
| 116 | yes | 75 | 15 | Casement | Wood | Single Pane | 9 light | Hinged left/Out | Single | 3 - Fair | 3 - Fair | 2 - Some decay | 3 - Fair | Good | 1 - Sound | 1 - Sound | 1 - Excellent | inside rear basement |

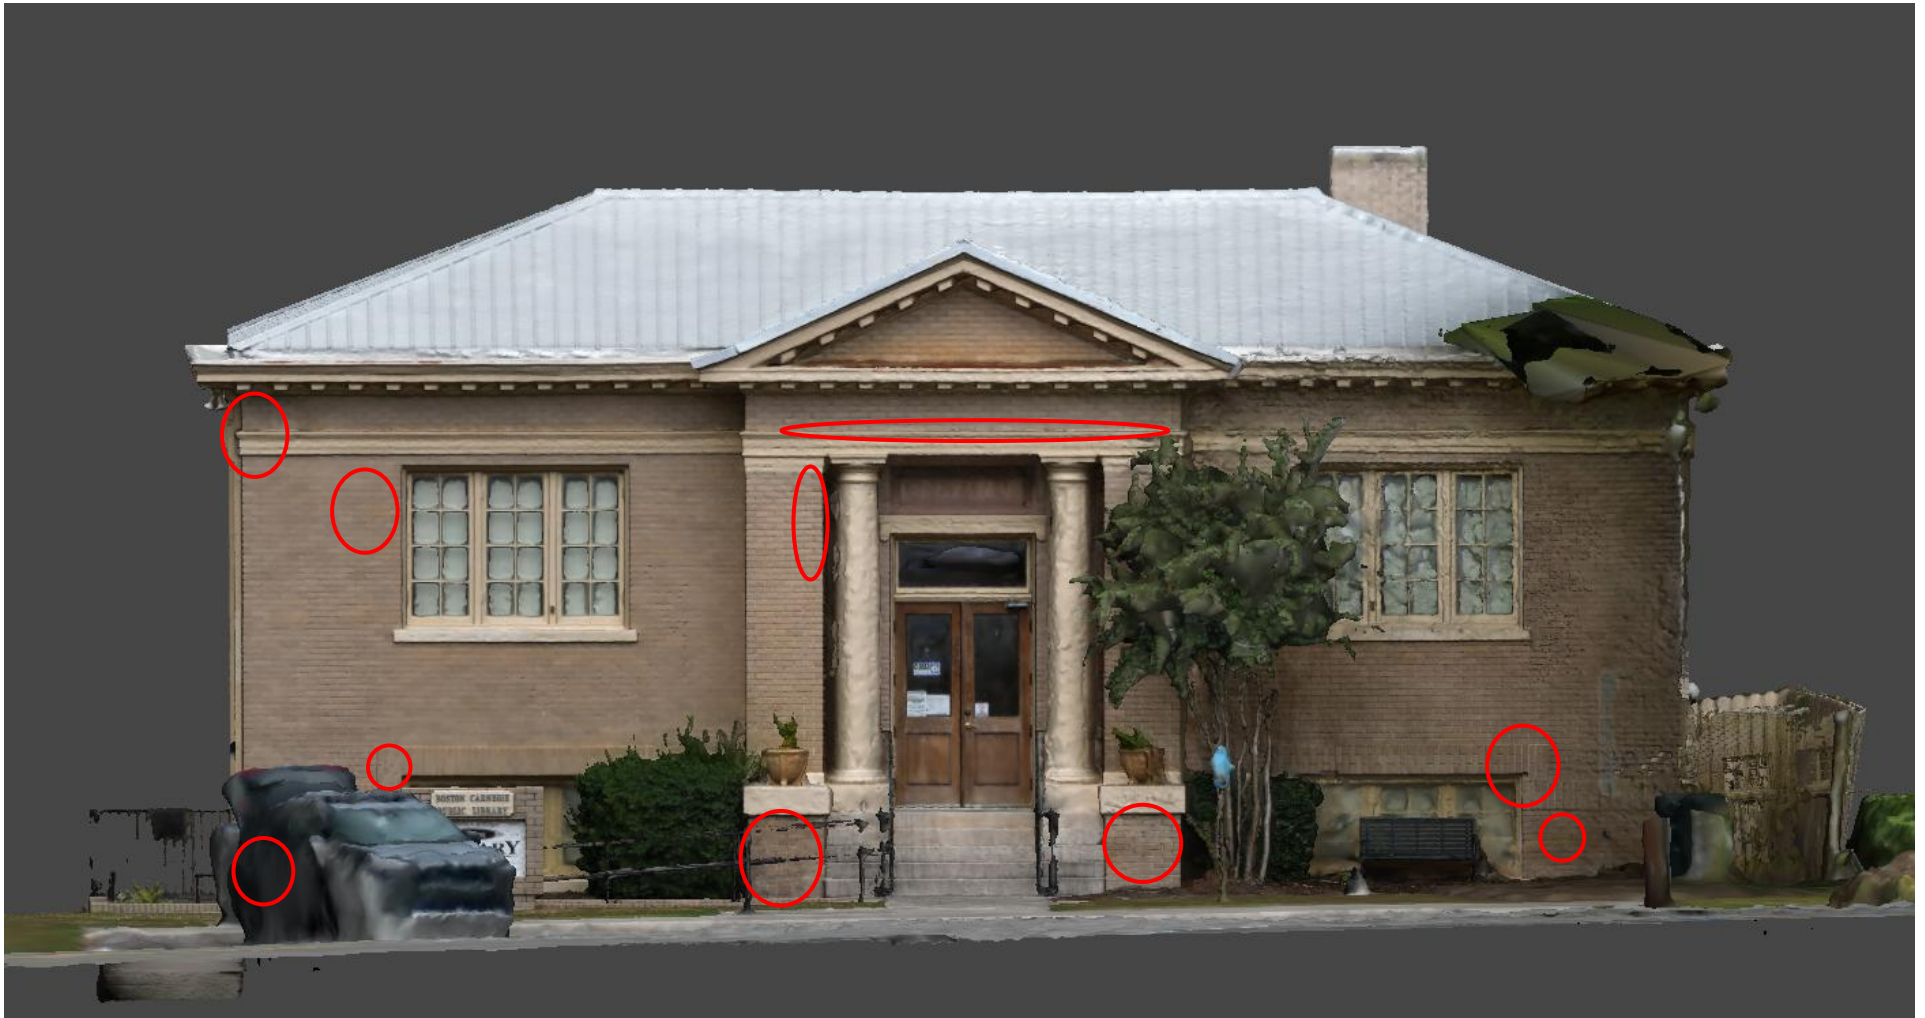
## EXTERIOR WALL EVALUATION – EAST ELEVATION

- Red circles indicate areas of mortar recession, spalling and/or damaged face bricks
- Green circles indicate areas of organic staining
- Yellow circle notes loose light fixtures
- Areas where circles are superimposed over foreground objects indicates wall behind is damaged
